## Shake, Rattle & Roll – Where There’s Heat, There’s Probably Vibration

Richard L. Harrison, Consolidated Diesel Company, Whitakers, North Carolina

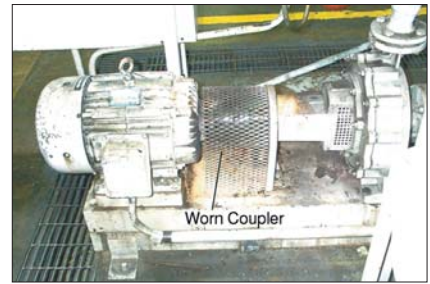
Figure 1. Photo of pump and motor assembly.

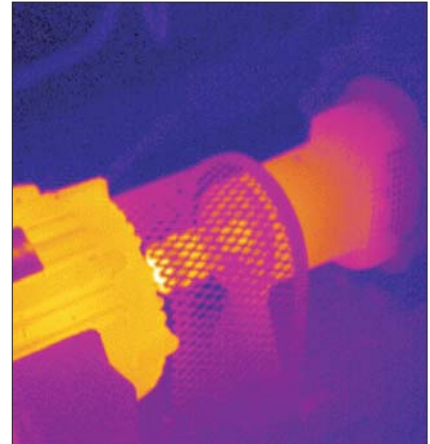
Figure 1 shows the coupler area of interest. I was not alarmed at first with the apparent temperature at the coupler, a

mere 110° F. I have learned from experience, however, not to jump to conclusions but to gather the data. The expectations, data comparisons or trending performed during analysis will determine the diagnosis. I decided to do a full analysis on this pump based on a ‘gut’ feeling – something most analysts deny having, but use quite frequently.

Figure 2. IR scan of pump and coupler.

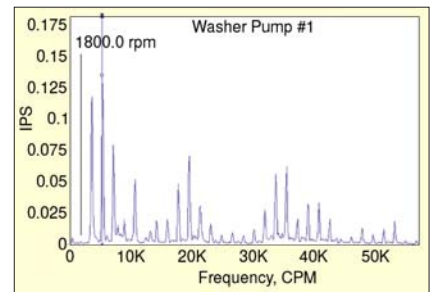
Something was definitely wrong here but more information was needed, so vibration data were taken and compared with previous data. The vibration data in Figure 3 show classic mechanical looseness and misalignment. Mechanical looseness is represented as high amplitude vibration (spikes), separated by 1× shaft rpm. Angular misalignment is represented as high amplitude vibration (spikes) at 3× shaft rpm.

Figure 3. Vibration spectra of washer pump.

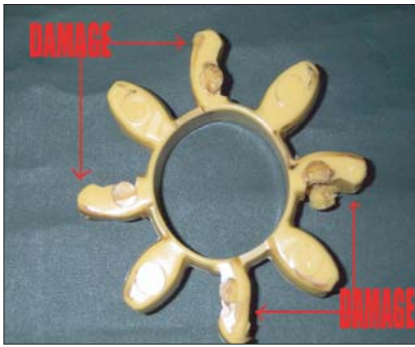
The purpose of the flexible member (spider) incorporated between the coupler halves is to compensate for slight misalignment between the pump and motor, and to eliminate metal-to-metal contact. In order for a spider to function properly, it must have a snug fit and be properly aligned within a few thousandths of an inch.

The damaged spider shown in Figure 4 was removed from the coupler. Inspection of the spider revealed 4 of the 8 legs to be seriously damaged, and the damaged legs caused gaps in the coupler (looseness). These allowed the coupler halves to make contact (rubbing), producing high vibration and excessive heat. A new coupler and flexible member were installed and the pump was realigned and placed back in service. Vibration data were acquired again (see Figure 5) and showed an 80% reduction in vibration amplitude and elimination of misalignment.

Figure 4. Damaged flexible member (spider).

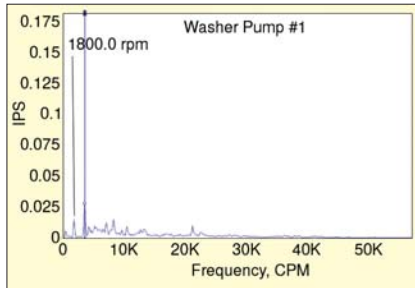
Figure 5. Vibration after repair is shown to drop from an overall level of 0.134 IPS (inches per second) to 0.027 IPS.
