# 11 Problems – 11 Solutions

## Case Histories of 11 Machinery Vibration Problems – Part 1

Kevin R. Guy, Delaware Analysis Services, Inc., Francisco, Indiana

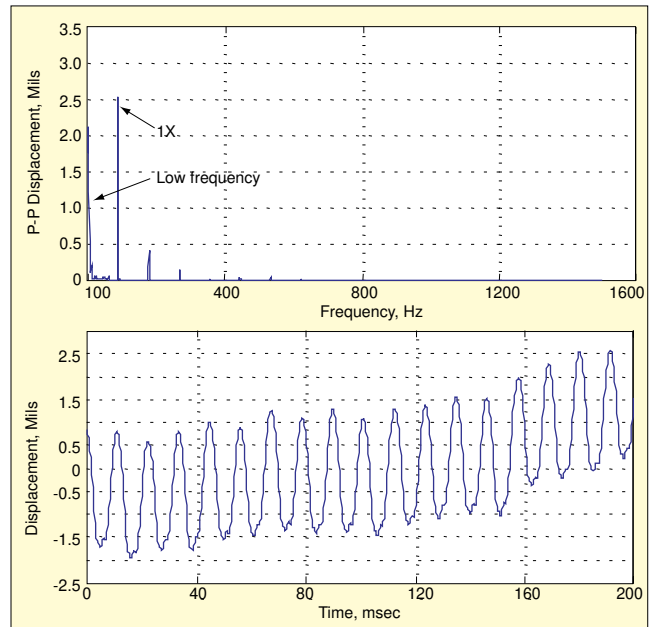
**Test Data and Observations** – The turbine data from the proximity probes and shaft riders were analyzed and concentrated on the difference between the control room data and the proximity probe data. The shaft rider data (Figure 1) contains 1x vibration along with a low frequency component.

Data from the horizontal proximity probe (Figure 2) contain no low frequency vibration; however, multiples of 1x are present. The data are essentially the same, the 1x amplitude from the shaft rider (Figure 1) is 2.6 mils<sub>pk-pk</sub> and the proximity probe data (Figure 2) is 2.1 mils<sub>pk-pk</sub>. Data collected from a shaft rider is absolute data, meaning that it contains the shaft vibration plus the casing vibration.

Figure 1. Shaft rider data.

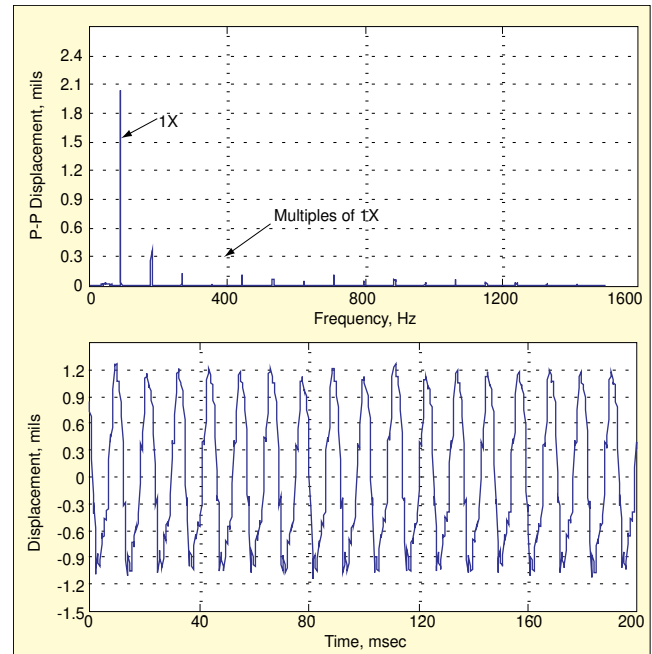
Figure 2. Low pressure bearing horizontal proximity probe data.

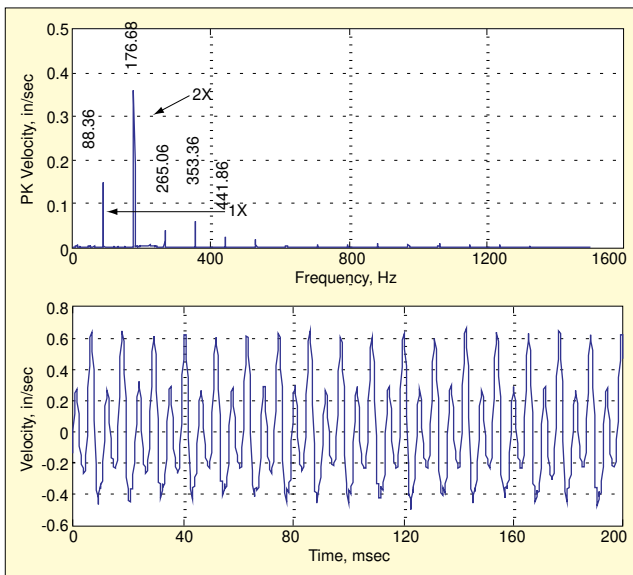
The high pressure bearing (inlet) velocity data is very interesting. The data indicate an alignment issue (Figure 3); but, data from the inboard pump and inboard turbine casing do not show this issue. Ironically; these data are almost an exact copy of the data collected for the previous analysis of this turbine/pump combination (Figure 4).

Figure 3. High pressure bearing shaft rider data.

**Corrective Action** – No corrective action was recommended. The unit, in spite of having alignment issues on the turbine, has run reliably. The plant, during the next overhaul, will check the bearing-to-bearing alignment on the turbine.

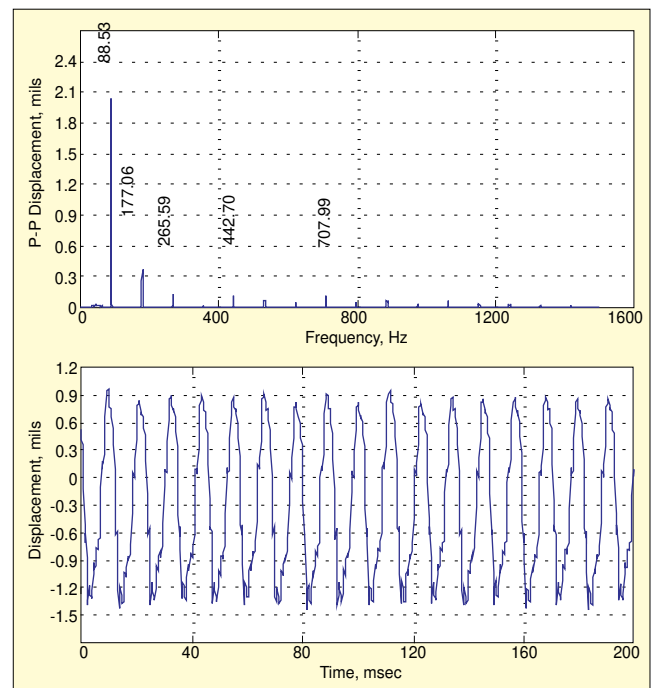
probe indicates the shaft vibration is 2.45 mils<sub>pk-pk</sub> (Figure 5).

For equipment running above 3600 rpm, the shaft vibration should not exceed 30% of the bearing clearance. This turbine has a 6 in. journal; therefore, the bearing clearances should not exceed 9.0 mils. The acceptable shaft vibration would then be 2.7 mils<sub>pk-pk</sub>. Presently, the vibration is 27% (2.45 mils/9.0 mils) of the bearing clearance. While this is not a serious problem, the vibration should be watched closely to see that it does not suddenly start to increase. There is indication of alignment issues on the turbine; however, these are not seen on the pump. This would mean the bearings on the turbine are not aligned or the turbine

Figure 5. Low pressure bearing proximity probe data.

rotor is misaligned in the bearings.

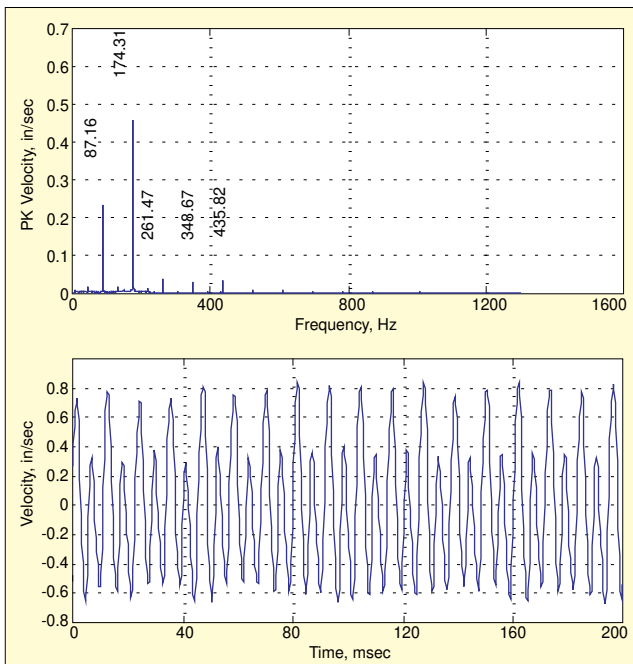
Figure 4. High pressure bearing seismic accelerometer data.

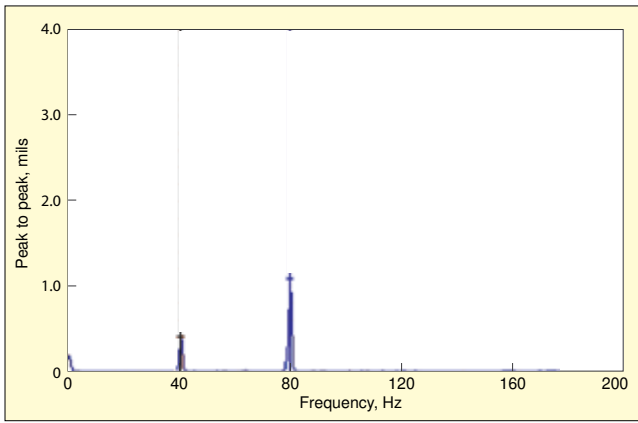
Figure 7. Low pressure bearing below vibration point – 4687 rpm.

**Test Data and Observations** – Since the turbine just had a complete supervisory instrumentation retrofit, all data were collected from the newly installed proximity probes. Data were collected with the turbine operating just below the point where vibration would start to increase (Figure 7). Data indicated a subsynchronous vibration at 2400 rpm.

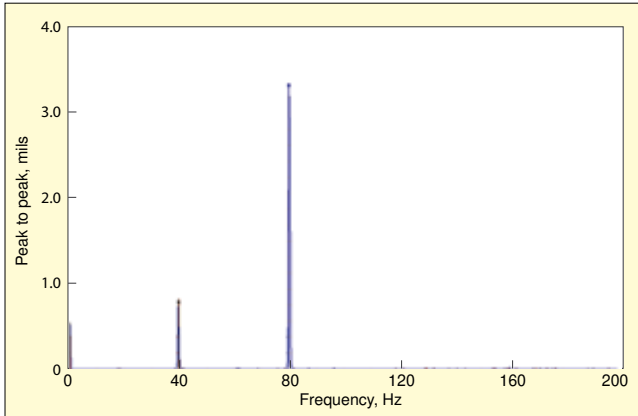
Figure 8. Low pressure bearing below vibration point – 4800 rpm.

When the turbine speed reached 4800 rpm, the 2400 rpm vibration started to gain energy and become unstable (Figure 8). The average vibration at this point was still acceptable; however, it was beating up and down. This 1/2× vibration (2400 rpm) appears whenever the turbine speed is within ±10% of 4800 rpm. The amplitude and severity of the vibration depends on how much energy builds up in the system. The longer the turbine speed stays at 4800 rpm, the more energy builds up in the system.

This is a sub-harmonic resonance. This turbine design has a structural natural frequency at 4800 rpm. When the turbine operates at 4800 rpm, it excites the first critical speed of the turbine which is at 2400 rpm, one half (1/2×) running speed.

**Corrective Action** – The data collected confirms the subharmonic resonance and the need for changing out the “elliptical” bearing to a “pressure dam” bearing. This type bearing has an oil dam

opposite the load zone of the bearing. This dam increases the oil pressure in the load zone, stiffening the shaft and increasing the critical speed above 2400 rpm. The increased critical speed should be somewhere around 2650 rpm.

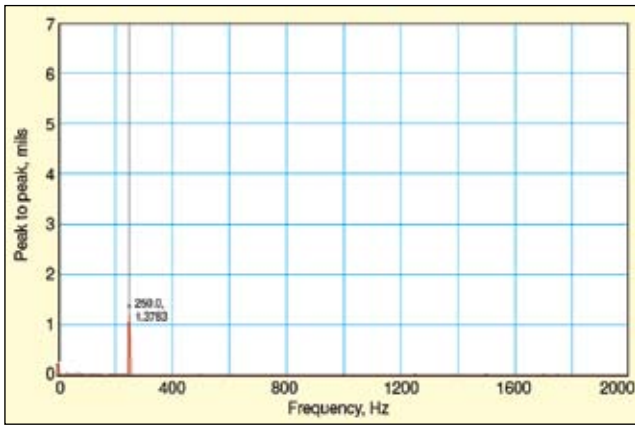
**Test Data and Observations** – Due to production requirements, no changes in the operating speed of the turbo compressor could be made during data collection. Data were collected from each proximity probe and the keyphaser. This would allow for collection of time and spectrum plots along with phase angle data. The dominant frequency in all the data was operating speed (Figure 9) and the phase remained constant during the data collection (Figure 10).

Figure 9 – Turbine inboard bearing proximity probe data.

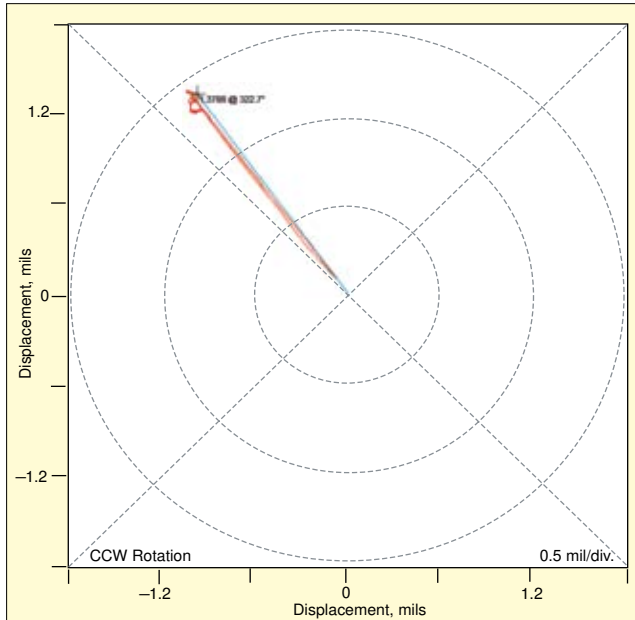
Figure 10. Turbine inboard bearing proximity probe polar plot.

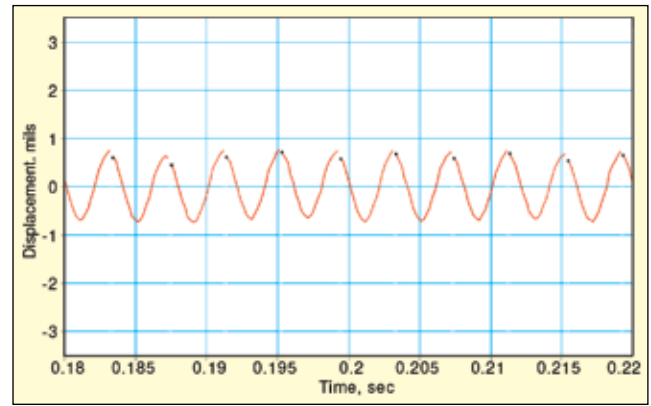
The shaft speed is 15,000 rpm; therefore, if the ratio of shaft vibration to bearing clearance is less than 20%, the vibration is acceptable. The overall highest vibration was 1.60 mils<sub>pk-pk</sub> from the inboard turbine bearing (Figure 11, Table 1).

Figure 11. Turbine inboard bearing proximity probe data.

mils (0.0075 in.) for the turbine bearing. This means the vibration ratio is 0.21, right on the border between a normal condition and a surveillance condition. Surveillance means that if the vibration ratio is in this region the plant should cut the time between monitoring checks in half. Since this equipment has a permanent monitoring system installed, it has automatic tripping protection.

**Corrective Actions** – Since the vibration is stable and the bearing temperatures, while fairly warm, are also stable, it was recommended that the equipment be operated normally.

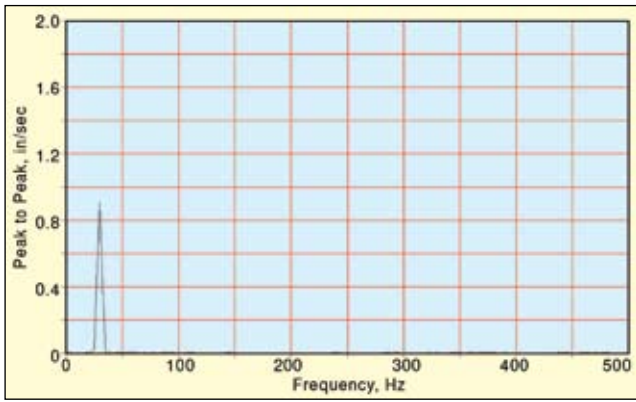
**Symptoms** – The pump was showing high vibration amplitudes in the upper 20% of the operating speed range. Amplitudes were recorded at over 1.0 in./sec<sub>0-pk</sub> (Figure 12).

Figure 12. Outboard motor bearing – vertical.

**Corrective Actions** – It was recommended to utilize Fabreeka vibration isolation pads to break up the system dynamics by putting a 1/2 in. thick ring of Fabreeka pads between the motor and pump head. Additionally, the pads will add damping to the system – isolating and absorbing some of the vibration. It was also recommended that if, after the addition of the pads, the unbalance was still high, to balance the motor to reduce the running speed

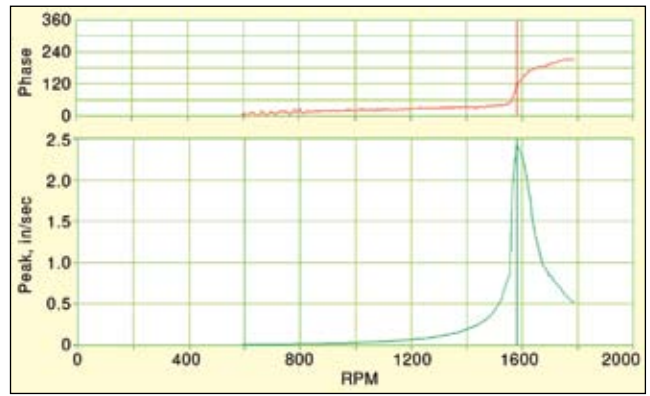
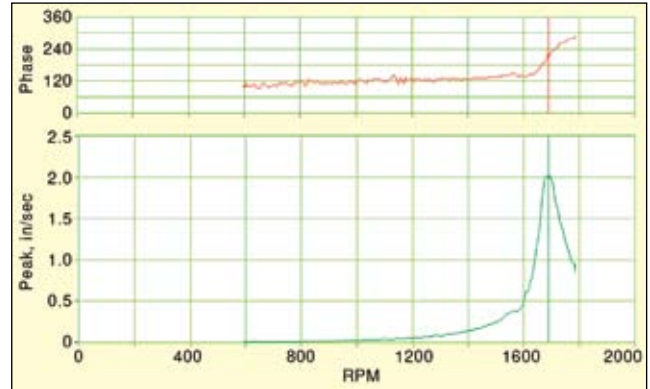
Transient data were analyzed first. There are two distinct natural frequencies present, 1597 rpm and 1690 rpm (Figure 15 and Figure 16). Impact tests confirmed the natural frequencies found on the coast down tests (Figures 17 and 18).

The pump and motor were operating in a resonant condition when they are in the 1550-1750 rpm range. This is a common problem with vertical pumps. It is compounded by the fact that the pump is driven by a VFD. If this were a fixed speed pump operating at 1780 rpm, one would never know that a natural frequency

Figure 15 – Outboard motor – horizontal direction.

Figure 16 – Outboard motor – vertical direction.

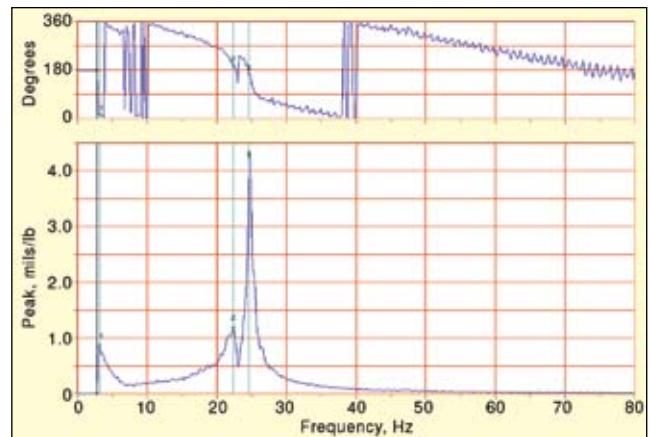
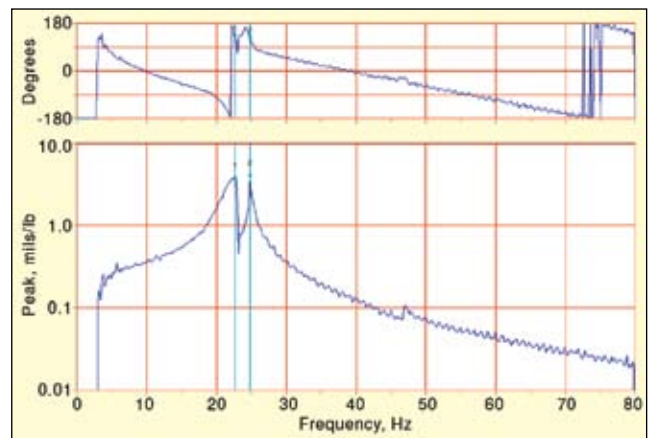
Figure 17 – Impact test – vertical direction.

Figure 18 – Impact test – horizontal direction.

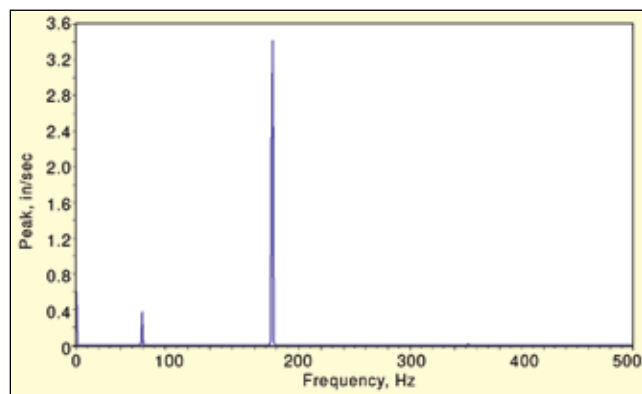
**Symptoms** – The pump had high axial vibration with velocity levels exceeding 3.0 in./sec<sub>0-pk</sub>. The radial vibration amplitudes were below 0.50 in./sec<sub>0-pk</sub>. Vibration levels could be changed by changing the flow settings of the system (Figure 19).

Because the vibration was so excessive, it was decided to look into the impeller design. It was discovered that an oversized impeller was installed. The original impeller for this pump was 10.5 in. in diameter. Because the flow was too high, the impeller was cut down to 10.0 in. in diameter. The present impeller had a diameter of 12.0 in. This increased the specific speed of the pump and increased flow to over 4000 gpm when only 2200 was needed for production.

Figure 19. Inboard pump bearing axial vibration.

**Corrective Actions** – It was recommended that the pump be immediately shut down or a catastrophic failure of the shaft could occur. The plant ignored all warnings.

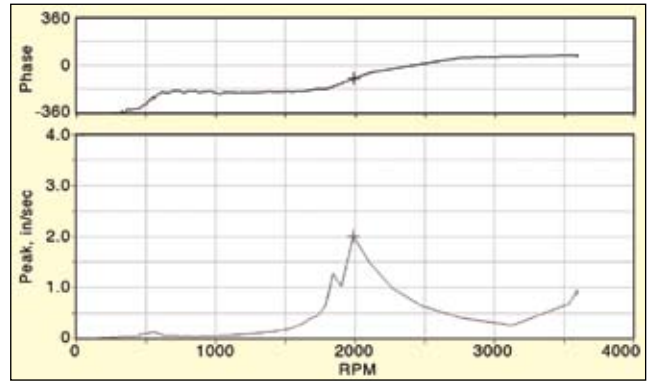
One other item noted in the analysis is the presence of a natural frequency or critical speed around 2000 rpm on the coast down (Figure 21). The amplification factor on the coast down, depending on position, is around 6.0 which is acceptable for sleeve bearing machines. Sleeve bearings have damping which helps control the vibration. Rolling element bearings have no damping; therefore, no way to control vibration at critical speeds.

Figure 21. Coast down – outboard exhauster bearing – vertical.

**Corrective Actions** – The most likely source of the looseness is the fit between the blower wheel and shaft. The wheel is aluminum and with a steel shaft the expansion coefficients are different. If the shrink/interference fits are not correct the wheel will expand and quickly lose its fit with the shaft.
