# 11 Problems – 11 Solutions

## Case Histories of 11 Machinery Vibration Problems – Part 2

Kevin R. Guy, Delaware Analysis Services, Inc., Francisco, Indiana

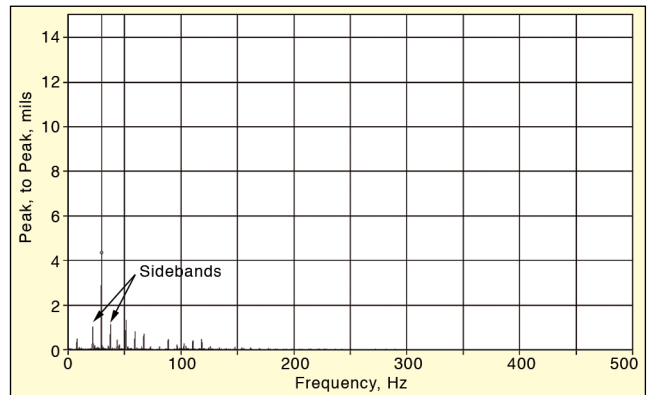
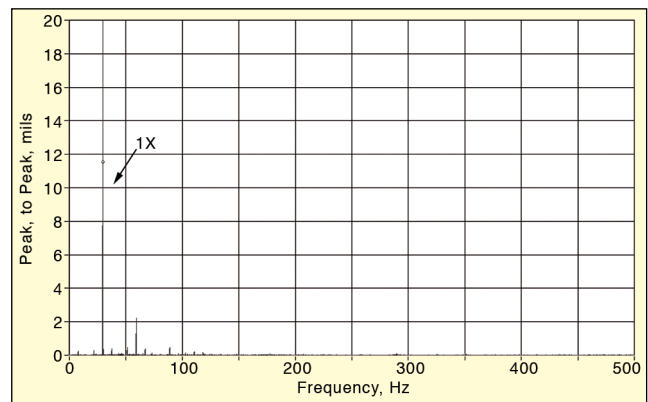
**Symptoms** – Data collected, by the plant vibration monitoring contractor, indicated high 1× vibration and sidebands spaced at  $\pm 7.98$  Hz (Figures 22 and 23). Axial vibration amplitudes at times exceeded 15 mils<sub>pk-pk</sub>. Axial vibration increased as the inlet damper opened. Vibration in the axial direction became high enough that it destroyed the proximity probe installed to measure the shaft thrust. An overview of the data indicated shaft vibration as much as five times higher than the seismic vibration.

Figure 22. Inboard fan bearing cap vibration – axial.

Figure 23. Inboard fan shaft vibration – horizontal.

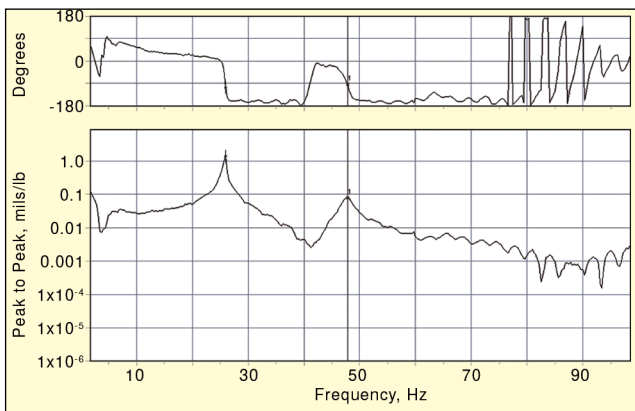
The first impact test was to determine the disk wobble (axial) natural frequency of the fan wheel. This test indicated several natural frequencies with the lowest located at 25.93 Hz (Figure 27). The amplification of this natural frequency is around 60; which is exceptionally high. This means that any axial vibration will be amplified by 60 times. Impact tests on the shaft also indicated a natural frequency at 25.93 Hz; however, the coherence was low at 57%. This means that the natural frequency at 25.94 Hz is not on the shaft; but, rather from the axial impact. Impact tests were also performed on the outboard bearing cap in the axial and radial directions. These tests did not provide any additional information on the natural frequencies. Both the bearing cap and pedestals did indicate very stiff systems. The impact test data clearly indicate that this fan is operating near a natural frequency. The operating frequency is 29.58 Hz and the disk wobble is 25.94 Hz. The rule is one never wants to operate within  $\pm 20\%$  of a natural frequency.

Figure 27. Disk wobble impact test.

system of six  $1.5 \times 1.5 \times 0.25$  in. angle iron bracing be placed on the fan wheel to increase the disk wobble natural frequency.

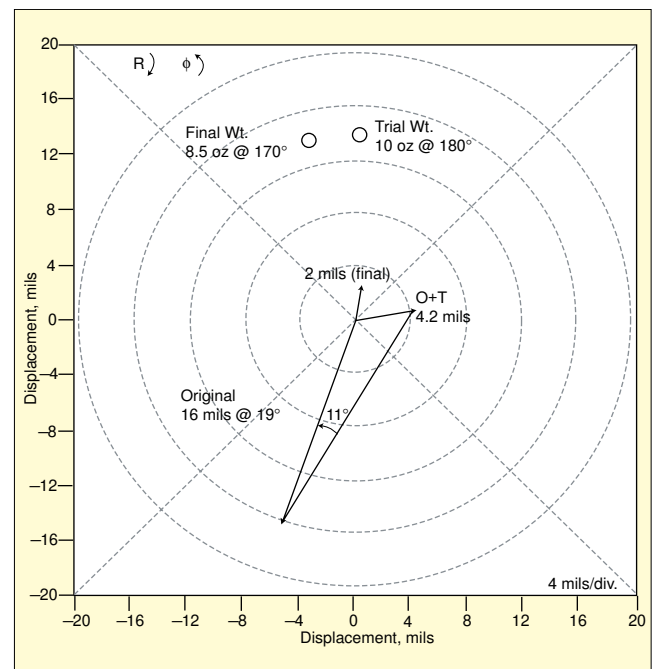
**Results** – Balancing reduced the vibration amplitudes to below 2.0 mils<sub>pk-pk</sub> on the shaft and 0.50 mils<sub>pk-pk</sub> on the casing (Figure 28). Axial vibration dropped below 4.0 mils<sub>pk-pk</sub>. Previously, the axial vibration was running over 22.0 mils<sub>pk-pk</sub>. The plant decided not to add the bracing to the fan wheel because of cost.

Figure 28. Final balance results.

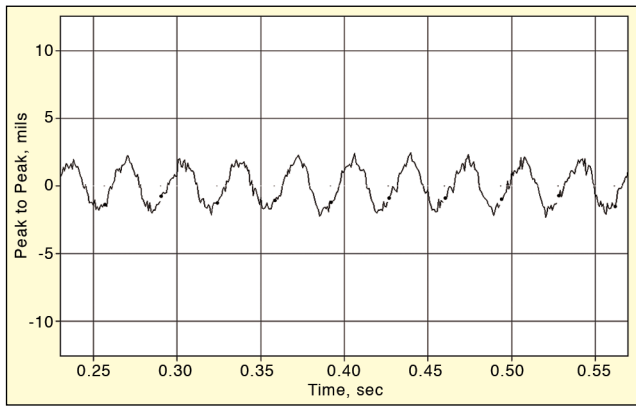
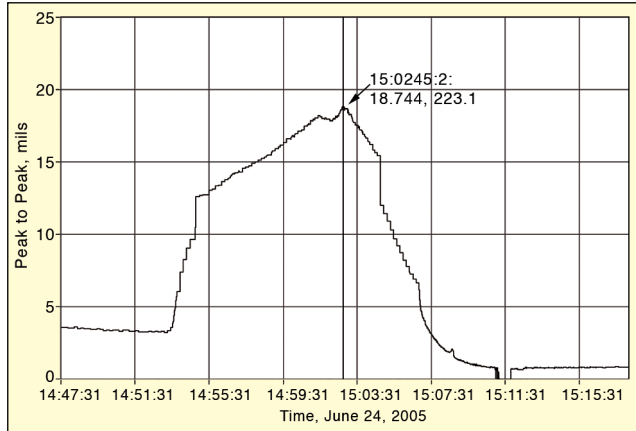
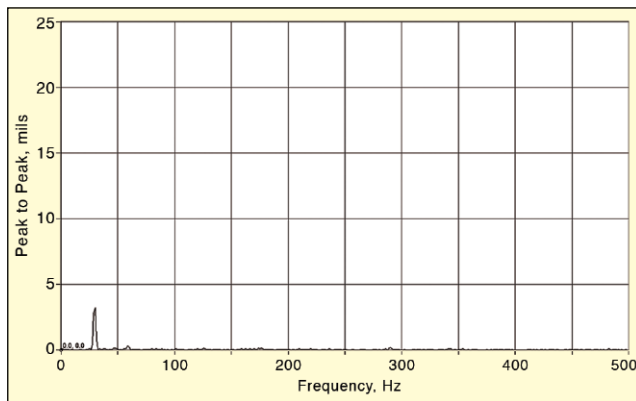
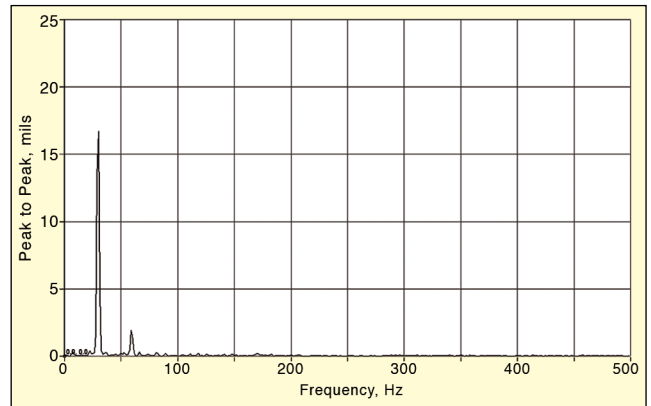
**Test Data and Observations** – Initial vibration data, while appearing stable, was not. The data, trended over time, showed the vibration amplitude increase with time (Figures 29-31). Figure 33 shows a coast down. The coast down and vibration trend are classic indications of a rub condition.

Figure 29. Inboard bearing proximity probe.

Figure 32. Inboard fan bearing proximity probe – high amplitude.

Figure 30. Inboard fan proximity probe - 1x vibration trend.

Figure 31. Inboard fan bearing proximity probe – low amplitude.

**Corrective Actions** – It was recommended the fan be shutdown and inspected for a rub. Since this fan was just overhauled, the rub was most likely caused by a shaft seal. Additionally, it was recommended that the alignment be checked to find out if the vertical alignment was off and possibly causing the rub.

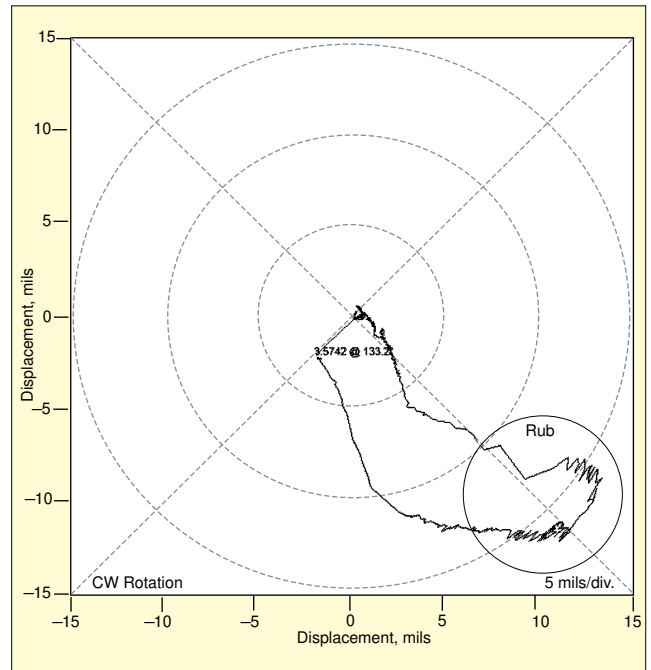
Figure 33. Inboard fan bearing proximity probe – coast down.

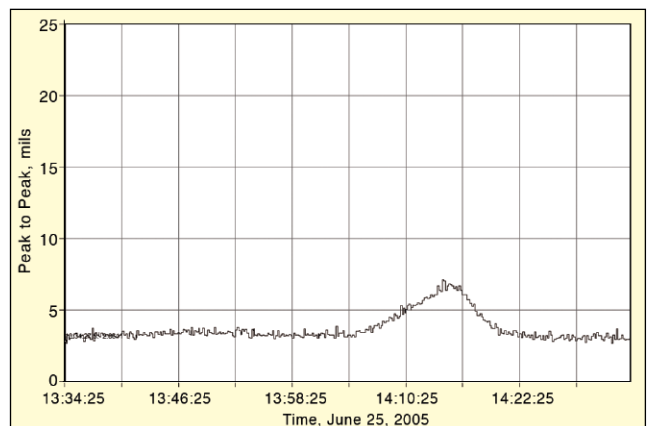
The shaft seals eventually were removed and ground down to eliminate the rub. While inspecting the seals, it was fairly obvious that they suffered a hard rub. The seals had to be ground down 0.05 in. to remove the rub defect. Even with this grinding, a slight rub was still present. This showed on the trend plot when the fan was put back in service (Figure 34).

Figure 34. Inboard fan bearing proximity probe – trend plot.

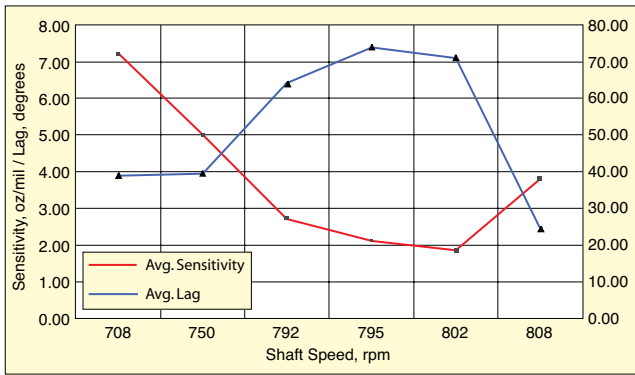
Figure 35. Lag angle and sensitivity versus shaft speed.

800 rpm. Additionally; the lag angle increases from 30° at 700 rpm, to 90° at 800 rpm. These data indicate the possibility of a natural frequency close to operating speed. Anytime sensitivity drops as speed increases, it indicates that the equipment is approaching a natural frequency (Figure 35).

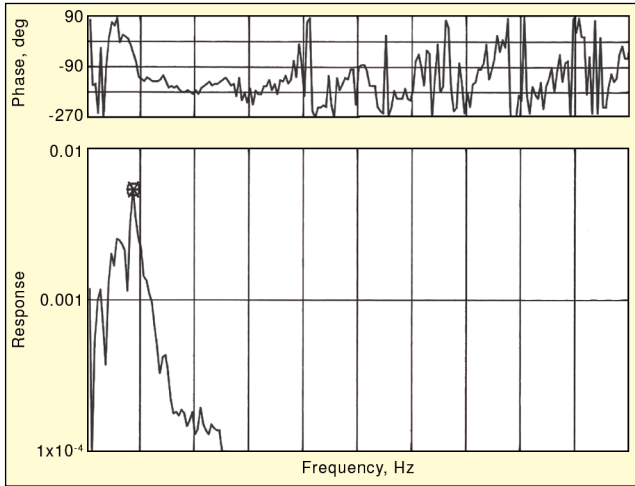
Figure 36. Shaft impact test.

**Test Data and Observations** – Impact tests were run on the shaft in the horizontal and vertical axes (Figure 36). One concern with the shaft impact data is the response at the natural frequency. The natural frequency identified by impact tests on a nonrotating shaft is the natural frequency of the shaft at rest. A summary of all impact tests can be found in Table 2. The horizontal and vertical natural frequencies at 17 Hz (1020 cpm) and 23.0 Hz (1380 cpm) are a problem since they are so close to the operating speed of the shaft.

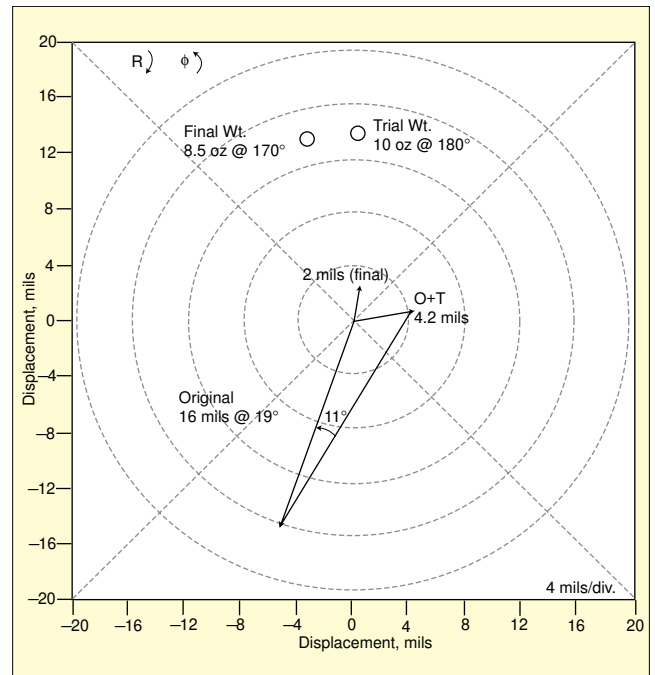
Figure 37. Outboard fan bearing – vertical proximity probe vibration change due to applied weight.

Stiffness testing was performed next. The most effective way to determine stiffness dynamically is to apply weights and measure the response. A polar plot of the response from the outboard fan bearing vertical proximity probe is shown in Figure 37.

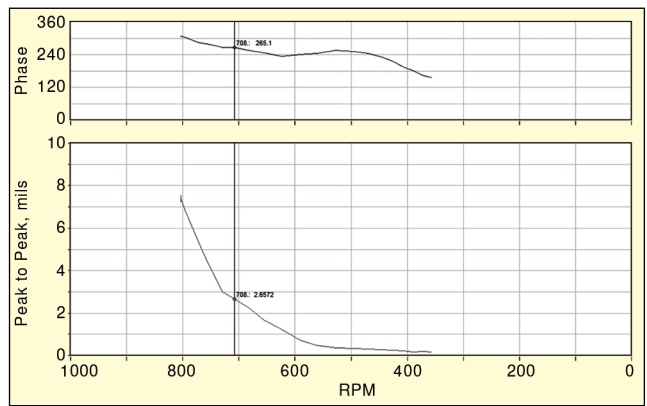
One further piece of data was the coast down (Figure 38). This shows a rapid drop in vibration as the shaft coasts down from operating speed. When the operating speed is cut in half, the vibration should drop by a factor of four. In this case the vibration dropped by 60% with a decrease in speed of only 100 rpm.

Figure 38. Outboard fan bearing – vertical proximity probe – coast down.

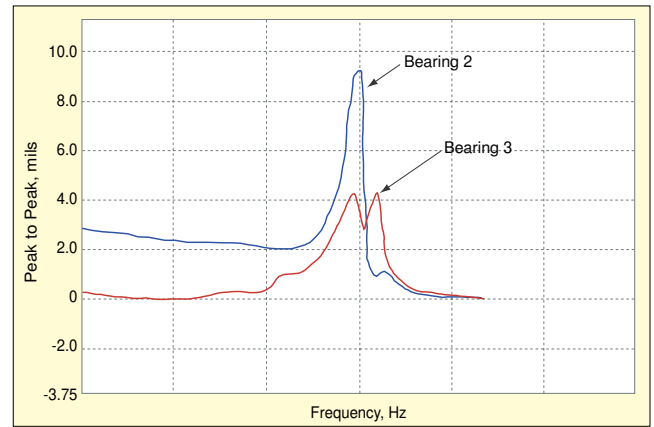
**Symptoms** – During the coast down, operations personnel witnessed vibration amplitudes on bearing #2 over 8.0  $\text{mils}_{pk-pk}$  (Figure 43). Additionally, the operating temperature of bearing #2 was over 210° F (Figure 44). The normal operating temperature of this bearing would be approximately 180-185° F. Drain oil temperatures were almost 50° F above the inlet temperatures. Inlet oil

Figure 43. Bearing #2 coast down - shaft rider data.

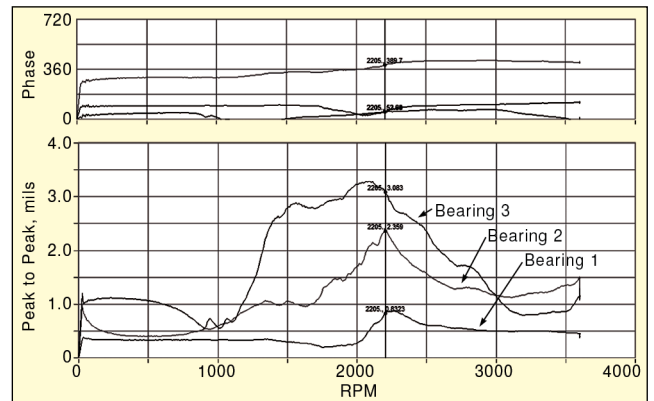
Figure 45. Bode plots - bearing #2 - bearing #4.

Bode plots from bearing #1 thru bearing #3 indicate the same first critical speed at 2205 rpm (Figure 45). The plot for bearing #3 is very broad and has the highest amplitude of 3.2 mils<sub>pk-pk</sub>. Bearing #2 has a distinct peak at the critical speed. However, bearing #2 is on the HP/IP rotor and the critical speed should be

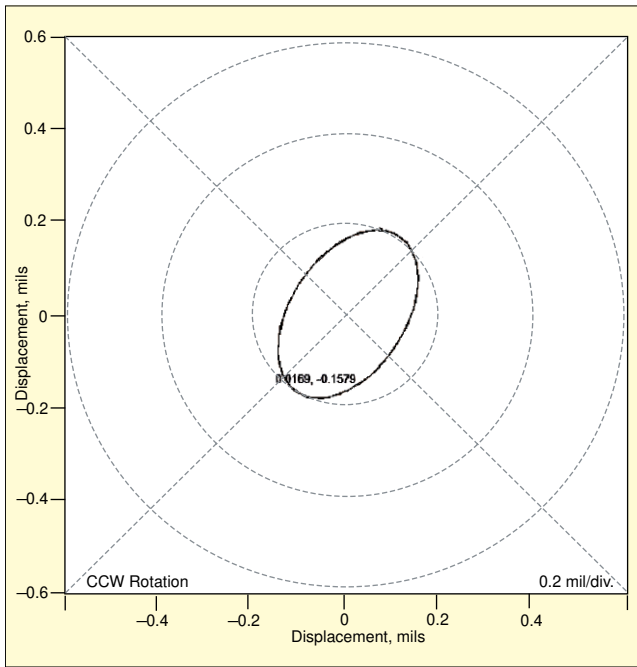
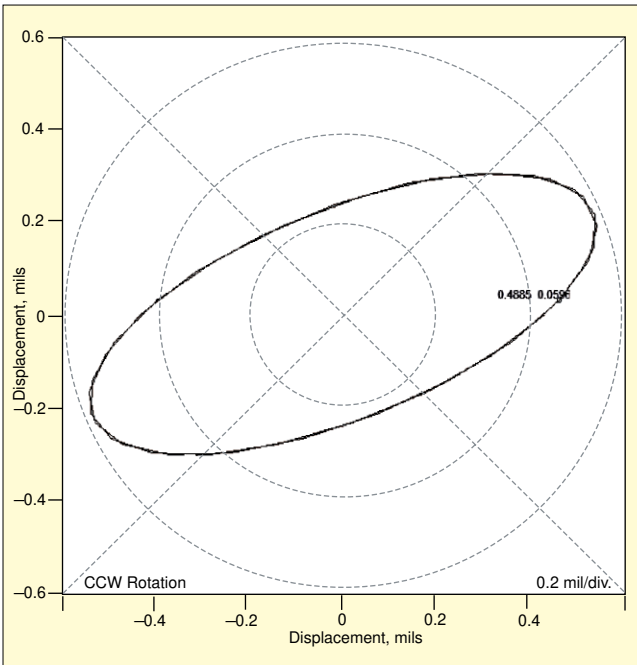
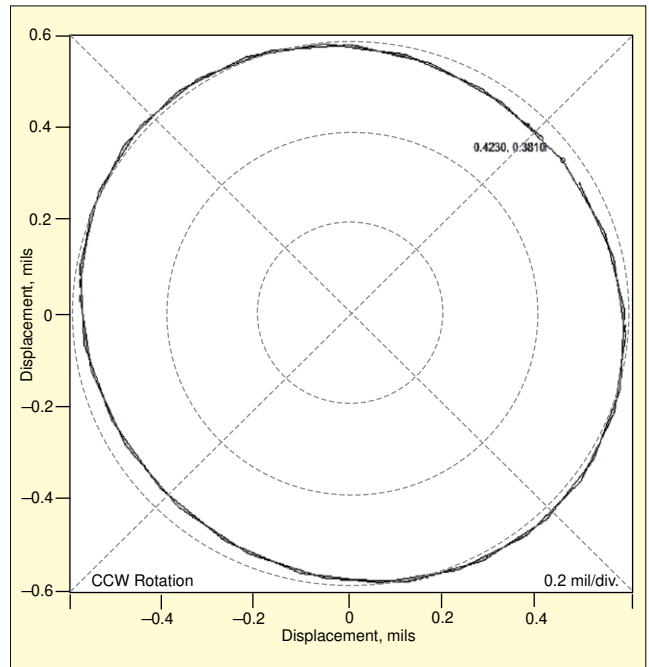
Figure 46. Bearing #1 orbit.

Figure 48. Bearing #3 orbit.

Figure 47. Bearing #2 orbit.

Shaft orbits for the three bearings (Figures 46-48) have different pattern orientations. Bearing #1 and bearing #2 orbits are elliptical; however, their orientation is not the same. They should basically have the same orientation. The bearing #1 orbit orientation is what one should expect for bearing #2. Bearing #2 is more flat and laying to the right. Bearing #3 is round which is not normal. This indicates the bearing is completely unloaded.

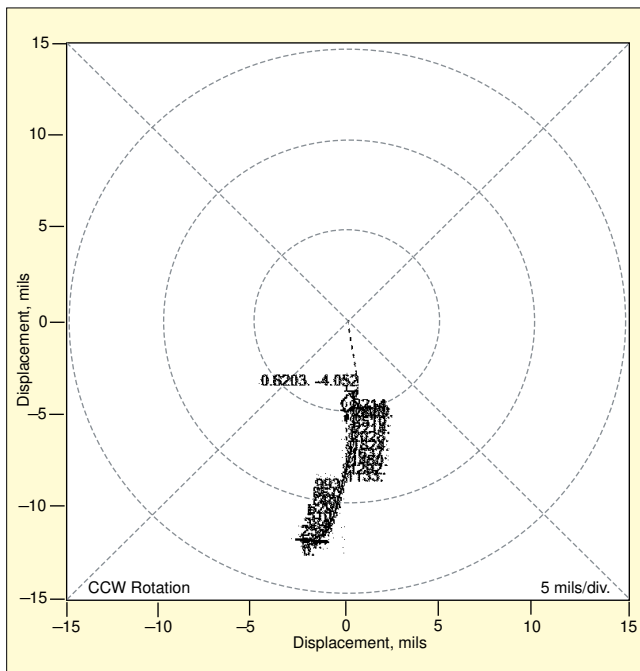
reaches operating speed. This is normal (Figure 49). Bearing #2 starts very low and then rises as the bearing is loaded (Figure 50). This heavy load causes the bearing temperature to run above 210° F. Bearing #3 starts above the centerline and operates above the centerline in the unloaded condition (Figure 51).

Figure 50. Bearing #2 centerline plot.

**Corrective Actions** – It was recommended to operate the unit normally. However, during coast downs, the bearing metal temperatures and vibration amplitudes should be monitored closely. Any excursion of bearing metal temperatures on coast down should be investigated.

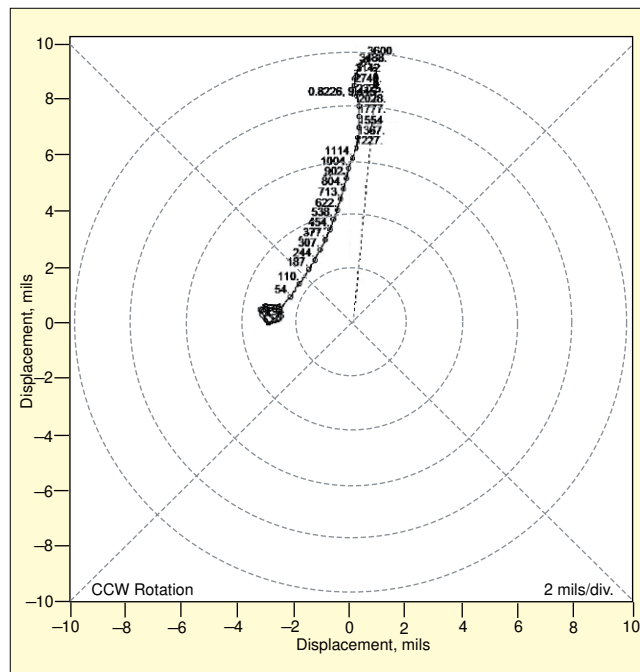
Figure 51. Bearing #3 centerline plot.

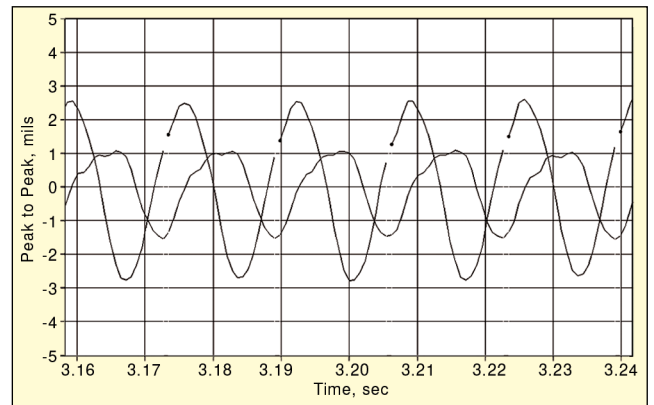
Figure 53. Bearing #9 proximity probes.

**Symptoms** – Bearing #9 vibration was erratic and unsteady. Vibration amplitudes did not correlate to any generator load settings. Bearing #9 vibration amplitudes vary from 4.0 mils<sub>pk-pk</sub> to over 7.0 mils<sub>pk-pk</sub>. All vibration is at running speed (Figure 52). The time history plot from the bearing #9 proximity probes indicates clipping (Figure 53).

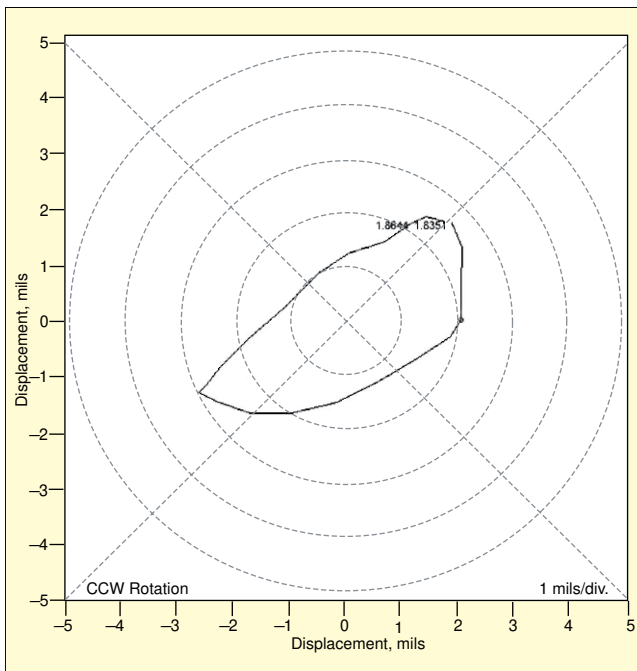
Figure 56. Bearing #9 orbit.

As for Bearing #9 the time plot is clipped in the y direction. The orbit is very flat and in line with the y proximity probe (Figure 56). Additionally, the centerline plot (Figure 57 and Table 5) indicates that this bearing has the shaft sitting higher in the bearing than anywhere else on the turbine.

with the erratic behavior of the vibration phase and amplitude indicate two problems. The erratic behavior and the clipped wave are an indication of a rub. The rub is mostly the result of alignment issues on the shaft. The misalignment of the shaft causes clearance problems with the seals. When the clearances are insufficient, the seals rub.

**Results** – This unit was exhibiting a fairly severe alignment issue that is causing seal rubbing. The unit, however, is needed for electrical loads and can’t be shutdown for repairs. Operation personnel have been told to reduce load if the vibration levels get above 7.5 mils<sub>pk-pk</sub>.
