Increasing Impact Insulation Ratings in Occupied Condominiums

Scott Harvey and Josh Curley, Phoenix Noise & Vibration, Frederick, Maryland

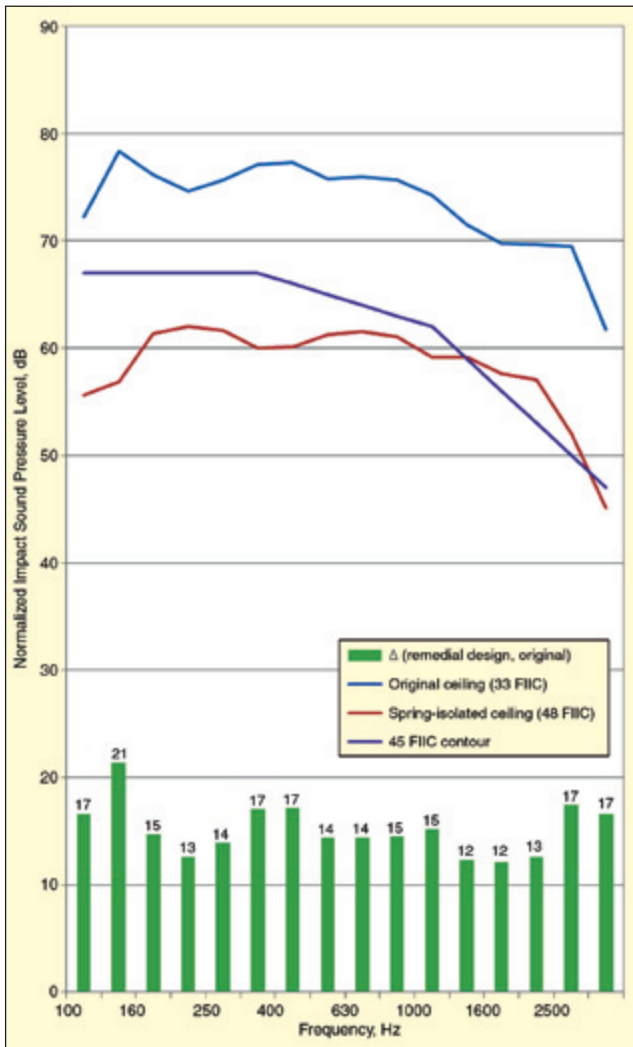
Post-Mitigation Testing. FIIC ratings of the three prototype units were measured one week after the pre-gypsum board inspections, revealing FIIC ratings of 48, 49, and 48, and FIIC value increases of 13, 18, and 17, respectively. (Pre- and post-mitigation data are shown in Figures 5, 6, and 7.) Each of the three prototype units

Figure 7. Pre- and post-mitigation test results (Unit E).

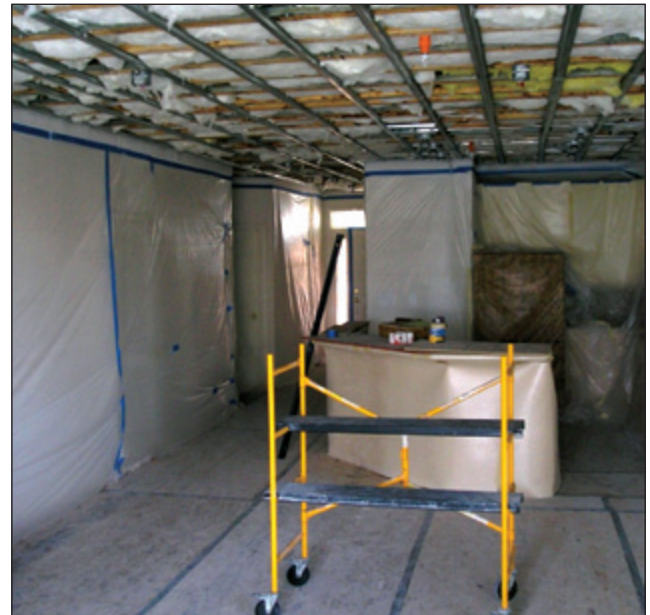
Figure 8. Existing ceiling demolition and spring isolated ceiling installation.

Demolition and Installation. After removing all condo possessions, all remaining condo surfaces and fixtures were protected. Walls were covered in plastic, plywood sheets were laid over all flooring, and cabinets, and sinks, toilets, etc. were boxed in with plywood (see Figure 8). The existing ceiling was then removed and the springs and spring grid were installed. Following the inspec-
