Time-to-Failure Testing Using Single- and Multi-Axis Vibration

Chris Peterson, Test & Reliability Consultant, working with H&H Environmental Systems, Rochester, New York

A Tensor™ 18kN vibration system from Team Corporation was used to run time-to-failure tests on 10 digital alarm clocks. A malfunction onset in the light emitting diode (LED) display was used to indicate failure. Time-to-failure was compared for both single-axis and multi-axis vibration excitation.

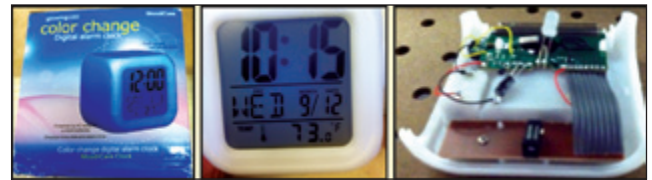
Figure 1. Details of the 12 digital clocks used as the devices under test.

Twelve clocks were purchased from Amazon.com by H&H Environmental Systems and shipped in advance to Team (see Figure 1). The name of the clock is “Moodicare,” and the description on the box is “glowing LED color change digital alarm clock.” According to the manufacturer, it was designed to soothe and relieve the pressure and stress brought about by living in a fast-paced society. To do that, the clock goes through a cycle of seven different colors based on studies showing that light and color change can have a soothing effect. Please note that the clocks were not purposely built to be able to withstand this type of testing.

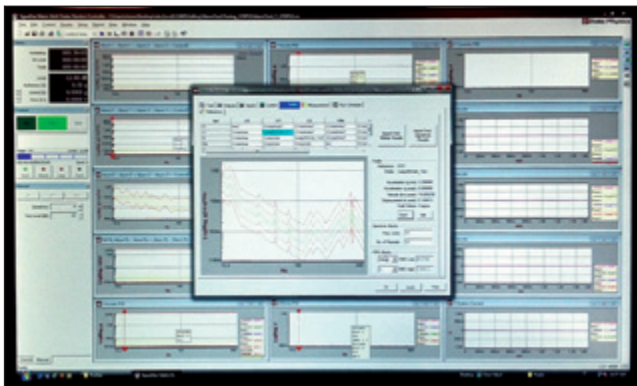
Figure 3. typical controller display.

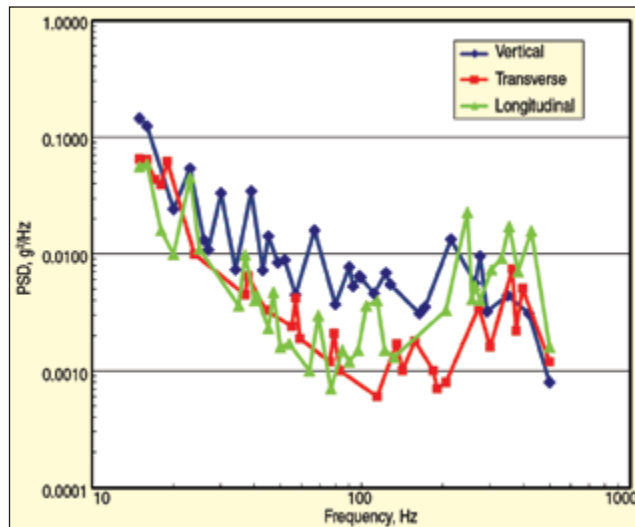
Figure 5. MIL-STD-810G acceleration PSD composite wheeled vehicle low-displacement spectrum used for the tests.

Test Schedule. The test schedule shown in Figure 5 was a modification of the ground vehicle vibration profile from MIL-STD-810G, which was based on measured data. It was provided by Skip Connon of Aberdeen Proving Grounds, and our thanks go to him for his help. In his words, “the schedules were a higher frequency version of the composite wheeled vehicle schedule from 810G to comply with the displacement limitations.” The only thing that was

modified from this profile for the test was displacement. The Tensor has limited displacement. The acceleration factors were all met.

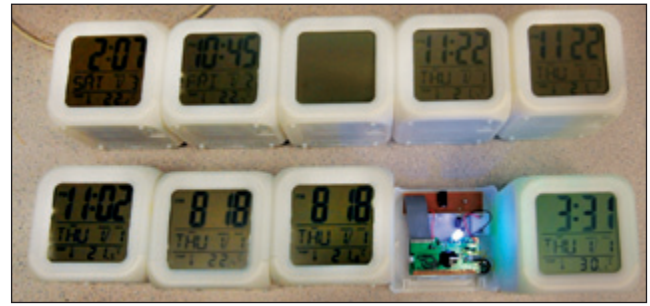
Figure 6. Ten of the clocks after testing; one completely failed LCD.

If you look closely at Figure 6 you can see some of the powdering patterns on the cases – first and second units from the left on the top row and the first, second and third units from the left on the bottom row. Some of the LCDs are dimmer than others, and the unit on the bottom right is showing uneven fading. The time showing on the faces each started at the default. The time-to-failure results are shown in Table 2 and Figure 7.

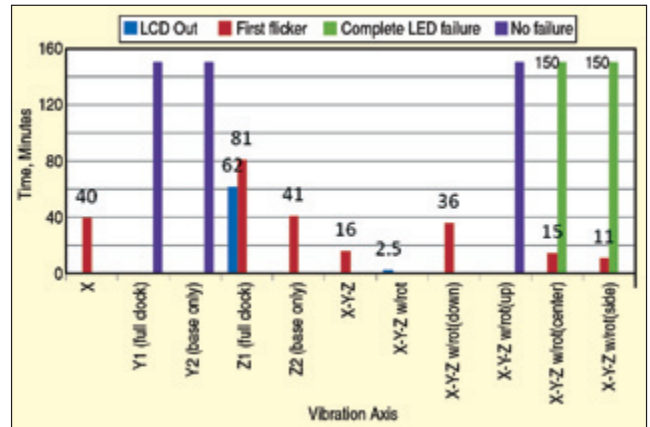
Figure 7. Time-to-failure bar graph of the tests.

X	40
Y	No flicker found at the end of 150 minutes
Z	81
X, Y and Z simultaneously	41
X, Y and Z with rotation	36 minutes for upside-down unit (as others were tested), did not fail right-side up
X, Y and Z with rotation	Center of table 15 minutes; slightly off to the side 11 minutes
