# Restoring and Upgrading a Reverberation Room Test Suite

Richard A. Kolano, Kolano & Saha Engineers, Inc., Waterford Michigan  
Sanjay Abhyankar and Thomas Martin, Ford Motor Company, Dearborn, Michigan

This article presents the upgrades and improvements needed to bring an old and seldom-used reverberation room test suite up to current standards. The upgrades and improvements included eliminating a below-floor pit that was open to the reverberation room, improving the acoustical diffusion within the room, enlarging the opening between the reverberation room and an adjacent anechoic chamber, renovating the anechoic receiving chamber, constructing an innovative sound transmission loss test fixture, and installing a high-power sound system.

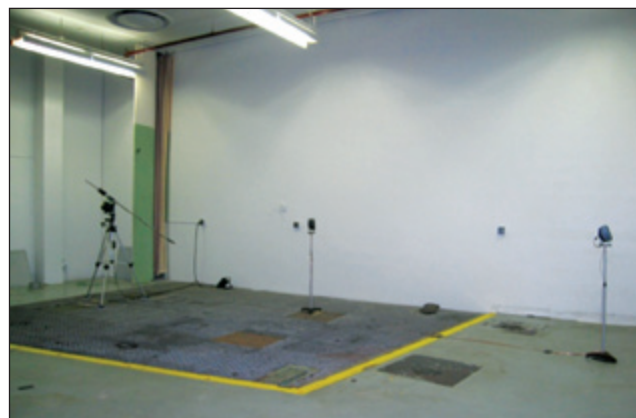
Figures 1 and 2 show the original test suite including the below-floor pit that contained a four-post shaker that would excite a vehicle through vertical vibratory excitation of the four wheels and tires. The vehicle was positioned within the reverberation room above an open grating that separated the reverberation room from the pit.

This arrangement allowed the room volume of the open pit to acoustically couple to an already oversized reverberation room. The added volume plus the odd and less-than-ideal combined room shape of the two coupled spaces resulted in a reverberant sound field that produced large variances in third-octave sound levels measured between microphone positions in the reverberation room. This variation introduced a high degree of uncertainty to acoustical measurements conducted in the reverberation room and rendered the testing suite unsuitable for precision measurements.

Figure 1. Original reverberation room with open floor grating covering below-floor pit, floor-to-ceiling corner drapery enclosure, and retracted drapery.

- Eliminating and replacing an open floor grating that covered the below-floor pit with a poured concrete floor.
- Eliminating draperies and drapery enclosures originally installed in four of the five room corners.
- Installing stationary diffusers to improve acoustical diffusion within the room.
- Enlarging the opening between the reverberation room and an adjacent anechoic chamber.
- Constructing an innovative STL test fixture.
- Reconfiguring the anechoic wedges covering the receiving side of the STL opening to make removal and replacement easier and to allow access to the opening
- Installing a new, high-power sound system.

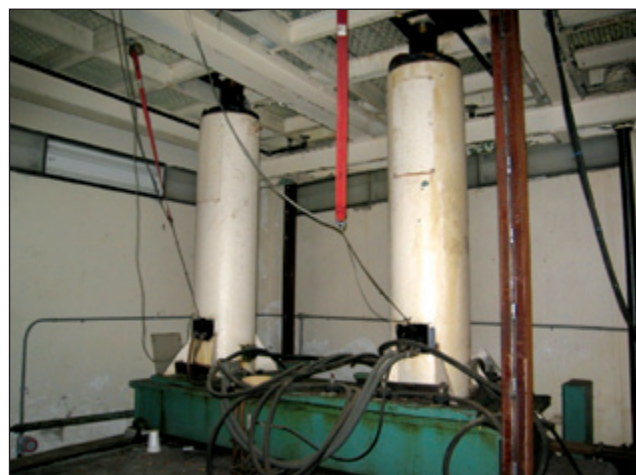
Figure 2. Original pit below reverberation room with four-post vehicle shaker.

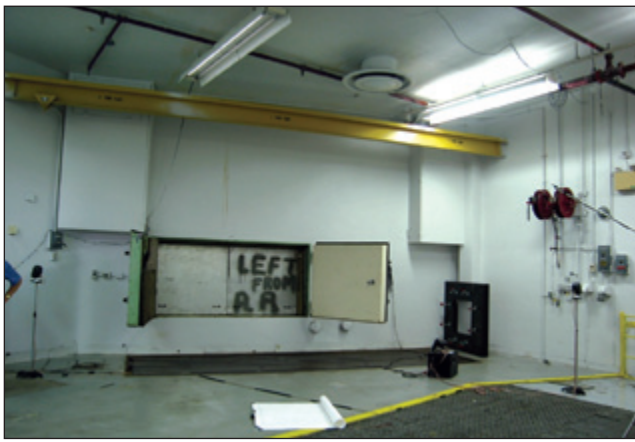
Figures 3 and 4 show the wedges covering the STL opening were removable, but in two sections which could only be removed (and re-installed) by sliding them through the STL opening from inside the reverberation room. This was not only an awkward and difficult exercise, but it prevented the anechoic wedge treatment from being re-installed without removing the entire STL fixture (or buck) from the opening. As a result, any ongoing STL measurements had to be interrupted in the event that the anechoic characteristics of the anechoic room were needed for other tests conducted in the anechoic space.

With the two sections of wedges removed, a rectangular tunnel was formed on the anechoic (back) side of the STL fixture by the wedges that remained and surrounded the removed sections. This tunnel had anechoic wedges along the bottom surface, which impeded physical access to the backside of the STL opening and made it difficult to install and position the receiving room microphone at the appropriate position behind the test sample.

Figure 3. Reverberation room side of original STL opening showing the backside of removable anechoic wedges and the original STL fixture (on floor, to far right).

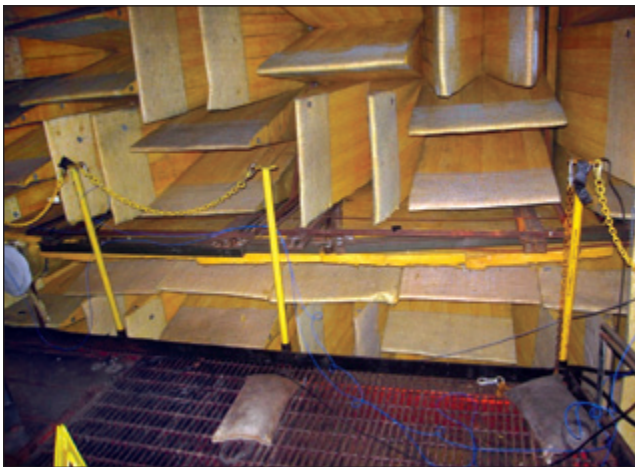
Figure 4. Anechoic side of original STL opening with removable wedge sections in place.

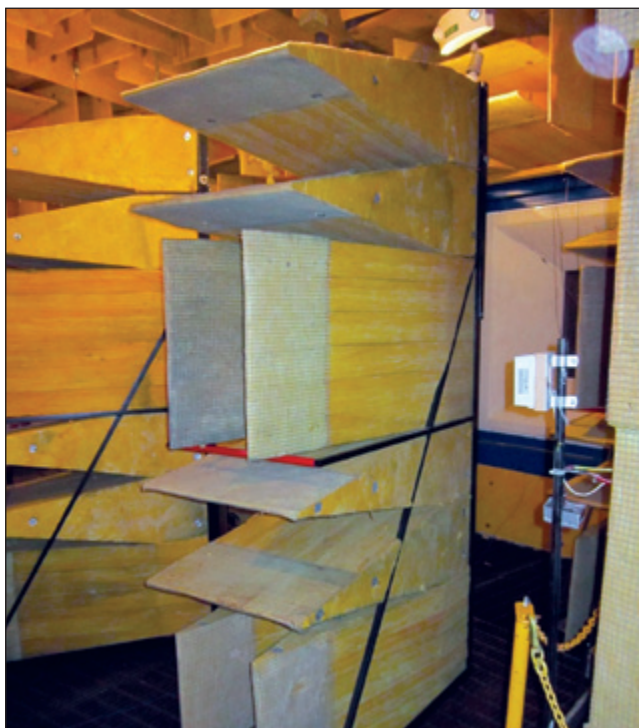
Figure 6. One of four removable wedge carts.

Once the wedges were removed, the anechoic room floor grating was extended to the room wall beneath the opening to permit access during enlargement of the STL opening. This change also allowed access to the backside of the opening for testing personnel. In addition, the removed anechoic wedges were reconfigured into four rolling cart structures that allowed these four wedge sections to be readily installed and removed. Figure 6 shows one of the wedge carts.

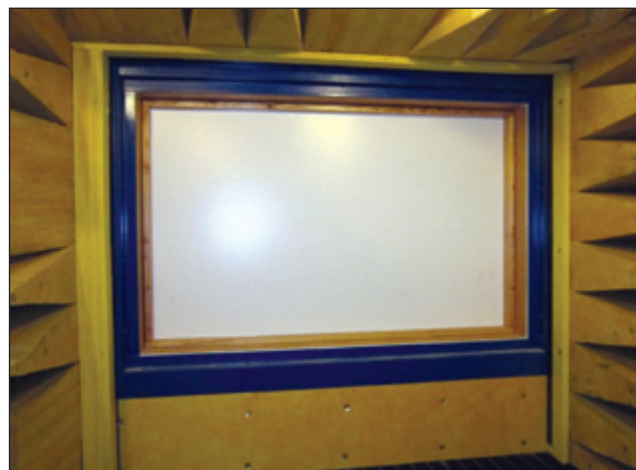
Figure 7. Anechoic room side view of the STL opening showing revised anechoic wedges surrounding opening and physical access behind the opening.

The four carts permitted a portion or the entire STL opening to be wedge covered, depending upon whether the buck or the STL fixture is installed. Figure 7 shows the anechoic side of the STL opening without any of the wedge carts in place. Figure 8 shows the backside of the STL fixture with two of the wedge carts flanking the fixture opening. Figures 7 and 8 both show the extended floor grating and illustrate how the space behind the STL opening is now physically accessible with all or some of the wedge carts removed.

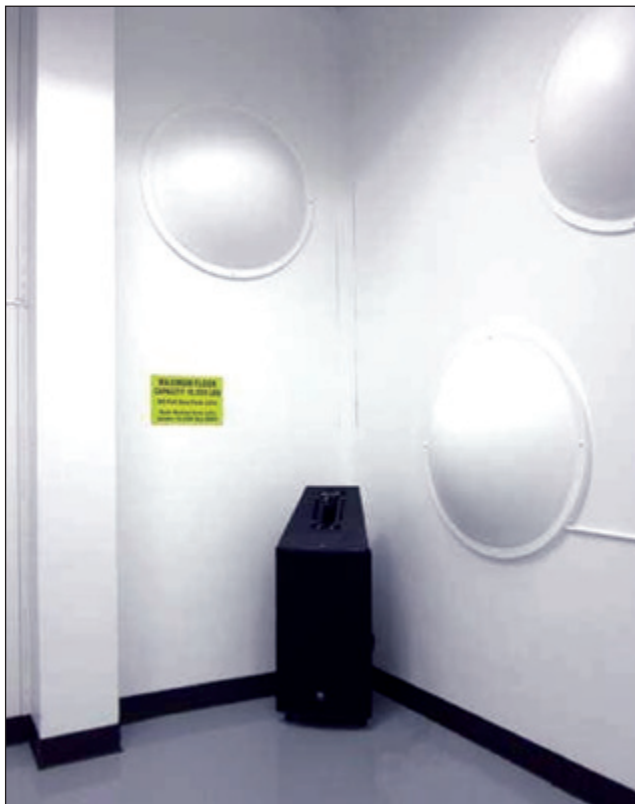
Figure 9. High-power loudspeaker system located in one corner opposite the STL opening (along with three stationary diffusers).

A new high-power sound system was provided and installed for generating high levels of broadband, random noise as the reverberation room source signal (see Figure 9). This system included a system controller that generates broadband random ("pink") noise, third-octave-band equalization crossovers for dividing the signal into pass bands to serve individual drivers and separate channels of audio power amplification.

In addition, the controller included signal monitoring and control features with settable thresholds and compression circuitry to limit the output voltage sent to each power amplifier. These limiter circuits were each ultimately set to limit the voltage produced by a power amplifier so that it does not exceed the safe operating voltage of the loudspeaker driver it's powering, based upon the driver manufacturer's long-term power handling rating for the device. This assures that the loudspeaker system will not be overdriven or operated in a range likely to cause driver failure.
