Solving Mechanical Noise Complaints in an Office Building

Walid Tikriti, Acoustonica, LLC, Brookline, Massachusetts

This article discusses noise impact from HVAC and mechanical systems in an office building. The project discusses noise impact related to mechanical systems. The mechanical noise relates to the air distribution system and vibration from rooftop package systems. Noise measurements were recorded in all cases. Sound analyses and noise mitigation solutions are also discussed.

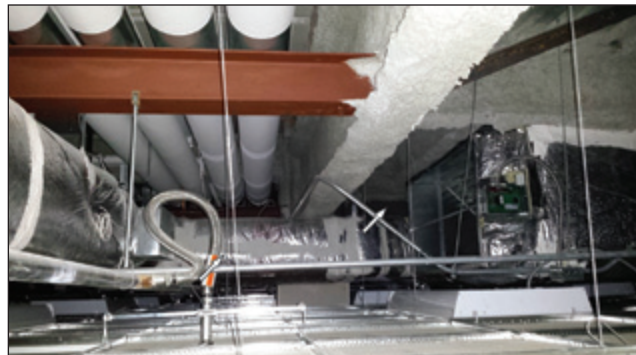
- The air-handling units were internally isolated from the structure with spring vibration isolators.
- The air-handling units and all components connected to it were rigidly connected to the structure (see Photos 1 and 2).
- Pipes did not appear to have flexible connections to the air-handling units.
- Vibration from the air-handling units could be felt next to the air-handling units and at the pipes connected to it and to the slab (floor of the roof).

Photo 1. Return duct elbow connected directly to the fourth-floor units located directly above sensitive spaces.

- The ducts should not be connected rigidly to the air-handling units, and there should be flexible connections at each supply and return side. All ducts and pipes should be free from touching any component of the air-handling units.

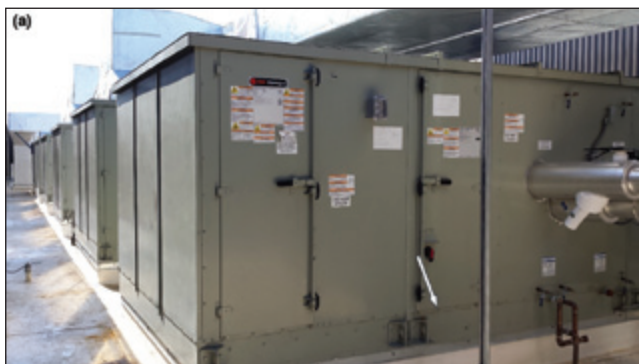
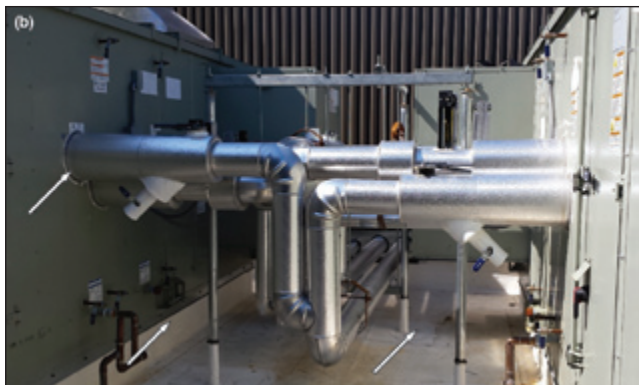
- Ducts penetrated the roof in many locations and were rigidly connected to those areas (see Photos 3a and 3b).

Photo 3. Pipes and ducts are rigidly connected to units and roof with potential vibration and noise transfer.

We observed several locations on the roof where the ducting system was in contact with the air-handling units' frame and structure, causing the vibration to be possibly transmitted from the units to the ducting system.

- There should be flexible connections of the reinforced spherical rubber between the air-handling units and the connecting piping. The connectors should be applied to the inlet and discharge sides.

- The duct penetrations should have better noise-blocking material between the ducts and the slab on the roof. We believed that some of the noise energy was being transmitted into the building directly through the penetration area.
- In the ceiling cavity below the foot print of the air-handling units, add 6-inch batt insulation with foil backing facing down to the cavity.
