# 11 Problems – 11 Solutions

## Case Histories of 11 Machinery Vibration Problems – Part 1

Kevin R. Guy, Delaware Analysis Services, Inc., Francisco, Indiana

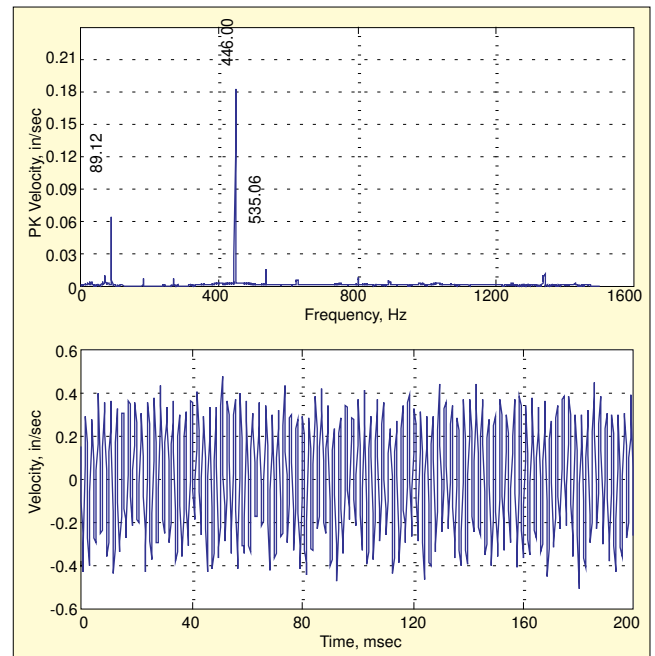
Figure 6. Inboard pump bearing seismic sensor data.

The pump does have a strong blade passage frequency and multiples of this frequency component are present. While it is normal to see some blade pass components on a feed pump, the multiples are a concern. The peak amplitudes of the blade pass vibration are as high as 0.5 in/sec<sub>0-pk</sub> (Figure 6). The amplitudes of the blade pass vibration should be watched and the trends followed to see if they are remaining constant or if they are increasing.

**Corrective Action** – No corrective action was recommended. The unit, in spite of having alignment issues on the turbine, has run reliably. The plant, during the next overhaul, will check the bearing-to-bearing alignment on the turbine.

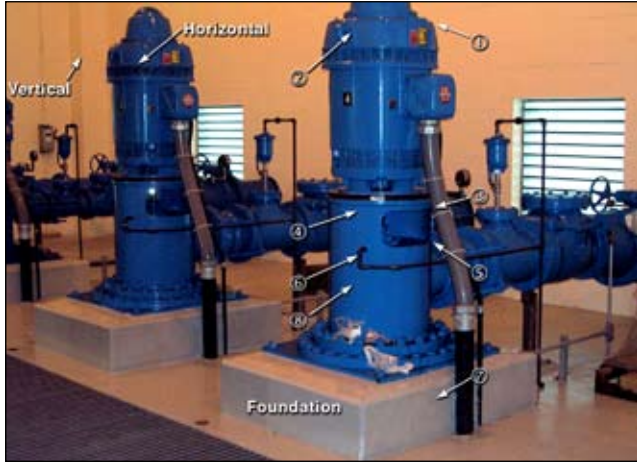
Figure 13. Operating and impact test point locations.

**Test Data and Observations** – Data were collected for two operating conditions: normal operation with the pump below and above the vibration problem region; and transient mode when the speed was dropped from rated speed to 1200 rpm. Impact tests were performed on one of the new pumps in the vertical and horizontal directions (Figure 13). Accelerometers (100 mV/g) were installed in eight locations on the pump and motor. An optical tachometer triggering off reflective tape was used for a phase and speed reference. A calibrated 3 lb modal hammer (0.71 mV/lb) was used for force input. Excitation and response locations for data collection are shown in Figure 14. Impact tests were performed at Points #1 and #2 (Figure 13). Sensors were mounted opposite the impact points. Operational deflection shape data were collected in the horizontal and vertical directions (Figure 14) from the top of the motor down to the sole plate.

No one part of the system can be faulted. The problem is not related to the pump, motor or foundation individually; rather it is all three parts acting together. If there is one area for concern, it is the pad (foundation) poured on the floor that supports the pump (Figure 13 and Figure 14). The rule of design, based on “good engineering practice,” dictates the foundation, at a minimum, must be five times heavier than the equipment it supports. This foundation is actually smaller in mass than the pump it is supporting.

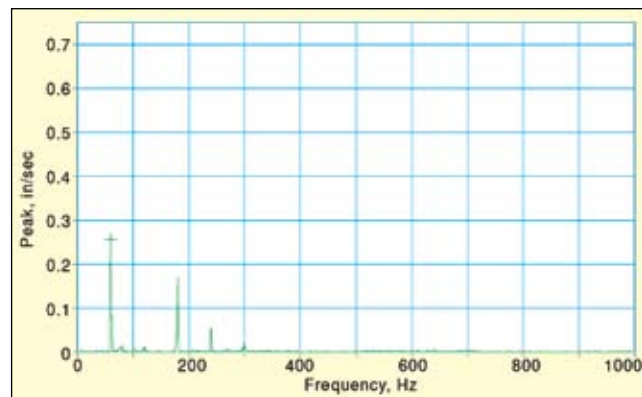
Figure 20. Outboard exhauster bearing vertical vibration.

**Test Data and Observations** – The data collected were in velocity units for both the time history and spectrum. The data strongly point to mechanical looseness as the source of the vibration. The vibration is synchronous with multiples of 1× (Figure 20) present in the data from all exhauster points. In addition to the looseness there is a natural frequency at 3× running speed. The natural frequency could be excited by mechanical looseness.
