# 11 Problems – 11 Solutions

## Case Histories of 11 Machinery Vibration Problems – Part 2

Kevin R. Guy, Delaware Analysis Services, Inc., Francisco, Indiana

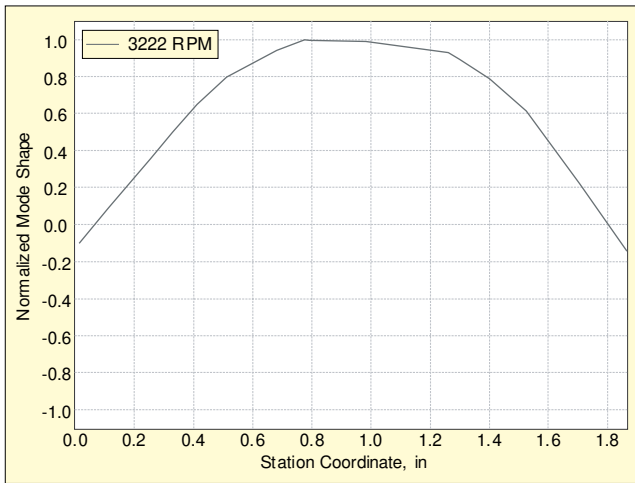
Figure 25. First critical speed.

**Test Data and Observations** – Because of the increase in vibration, in the axial direction, when the inlet damper opened it was decided to first look into the possibility of a natural frequency problem with the fan. A rotor dynamic model was developed from fan engineering drawings to look for a critical speed issue. The rotor layout is shown in Figure 24. The first mode shape is shown in Figure 25 and the critical speed map in Figure 26. The first critical speed was found to be 3222 rpm (53.7 Hz). The critical speed data indicate this fan was running well below the first critical speed.

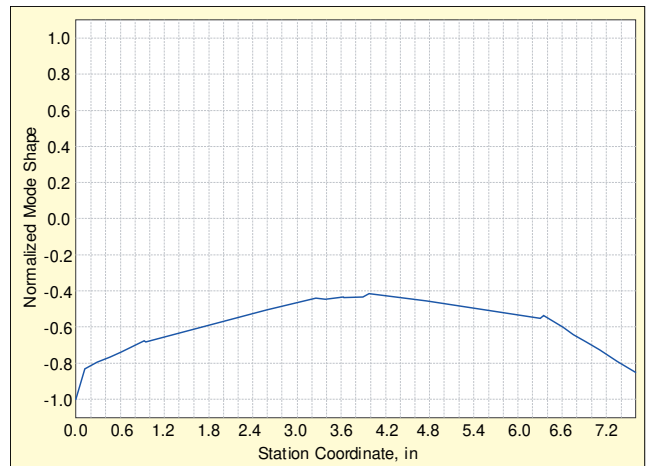
Figure 40. Shaft mode – first critical – 1149 rpm.

A rotor dynamic model was developed from the generated data (Figure 39). This model calculated a shaft critical speed of 836 rpm (Figure 40) which correlates with the balance sensitivities and lag angle changes seen in Figure 35. These data were provided to the fan manufacturer to utilize when designing a new fan. It was also requested to balance the fan to the API balancing specification of  $2W/n$ . Additionally, the plant requested that the new fans be supplied with dual proximity probes on each bearing. A keyphaser was also required.

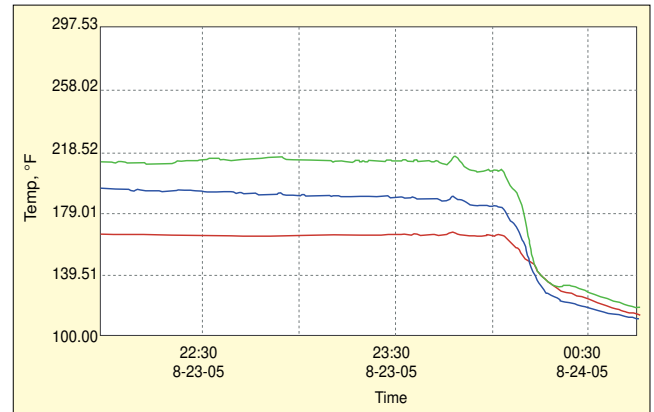
Figure 44. Bearing metal temperature trend data - pre-shutdown.

**Symptoms** – During the coast down, operations personnel witnessed vibration amplitudes on bearing #2 over 8.0  $\text{mils}_{pk-pk}$  (Figure 43). Additionally, the operating temperature of bearing #2 was over 210° F (Figure 44). The normal operating temperature of this bearing would be approximately 180-185° F. Drain oil temperatures were almost 50° F above the inlet temperatures. Inlet oil

temperatures run about 115° F. The recommended minimum inlet temperature is recommended to be 120° F. The metal temperatures of bearings #1 and #3 respectively were 193° F and 164° F.

**Conclusions** – This unit has alignment problems. Post start up reports after Spring 2002 raised questions about the alignment. The unit has run for 27 months in this condition. Recently, babbitt particles have shown up in the bearing #2 oil drain, but this unit has been very reliable. The only concern is the elevated temperatures of bearing #2. Operating over 210° F for a unit of this size is a concern and can lead to babbitt fatigue and possible wiping

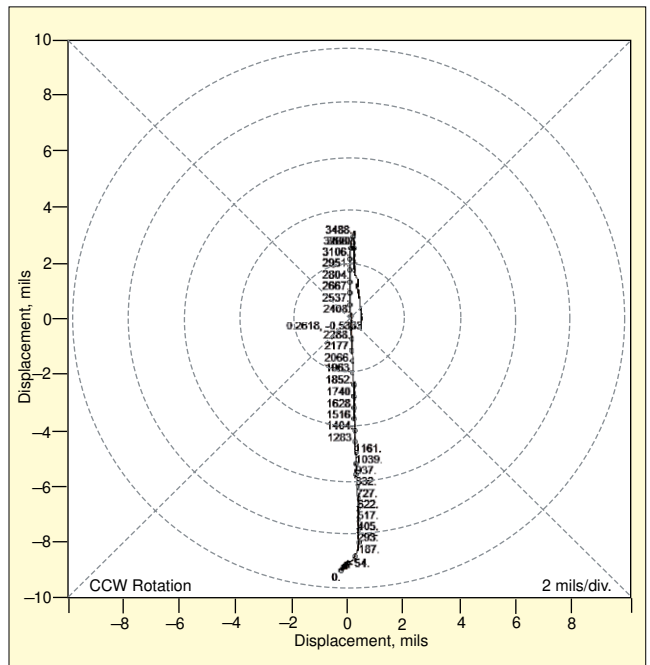
Figure 49. Bearing #1 centerline plot.

reaches operating speed. This is normal (Figure 49). Bearing #2 starts very low and then rises as the bearing is loaded (Figure 50). This heavy load causes the bearing temperature to run above 210° F. Bearing #3 starts above the centerline and operates above the centerline in the unloaded condition (Figure 51).

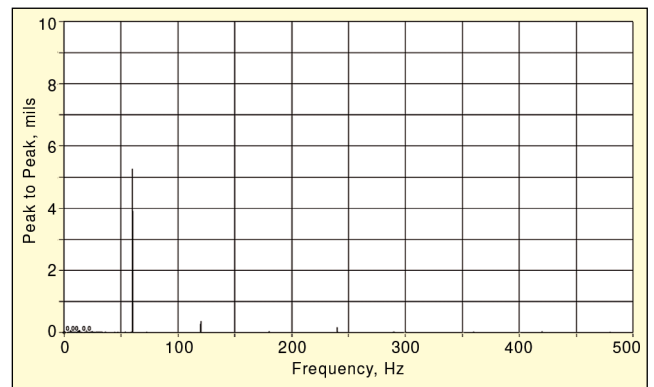
Figure 52. Bearing #9 – proximity probe "X".

**Symptoms** – Bearing #9 vibration was erratic and unsteady. Vibration amplitudes did not correlate to any generator load settings. Bearing #9 vibration amplitudes vary from 4.0 mils<sub>pk-pk</sub> to over 7.0 mils<sub>pk-pk</sub>. All vibration is at running speed (Figure 52). The time history plot from the bearing #9 proximity probes indicates clipping (Figure 53).

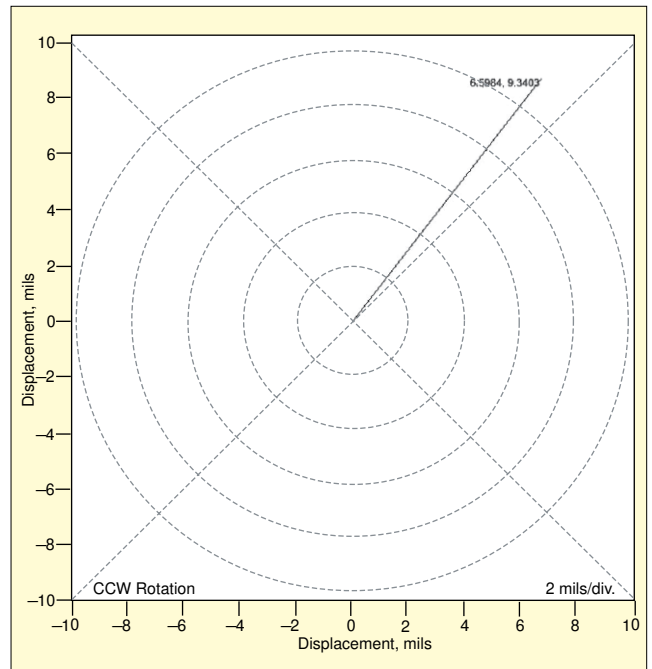
Figure 57. Bearing #9 shaft centerline.

As for Bearing #9 the time plot is clipped in the y direction. The orbit is very flat and in line with the y proximity probe (Figure 56). Additionally, the centerline plot (Figure 57 and Table 5) indicates that this bearing has the shaft sitting higher in the bearing than anywhere else on the turbine.

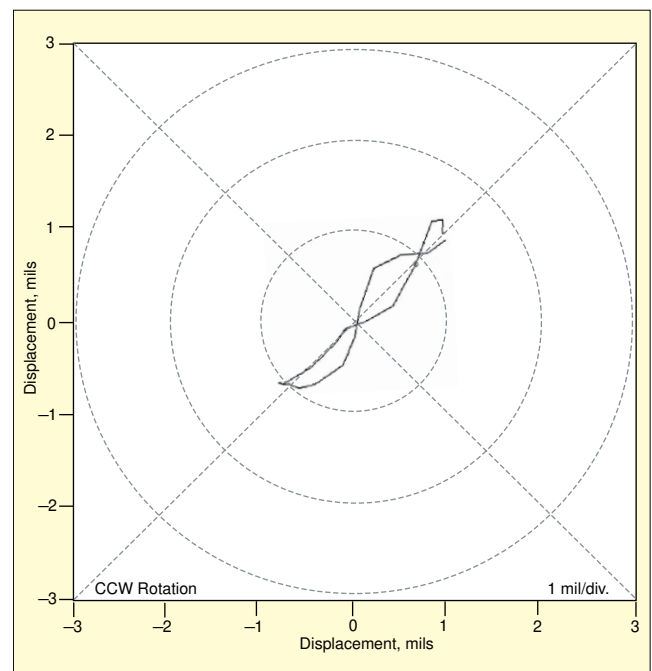
Figure 58. Bearing #10 orbit.

Bearing #10 has the most conclusive indication of alignment issues. The orbit is a “figure 8” (Figure 58). The shaft centerline plot (Figure 59) shows that the shaft is sitting in the upper left quadrant of the bearing.
