Using Modal Analysis for Detecting Cracks in Wind Turbine Blades

Surendra N. Ganeriwala and Jun Yang, Spectra Quest, Inc., Richmond, Virginia
Mark Richardson, Vibrant Technology, Inc., Scotts Valley, California

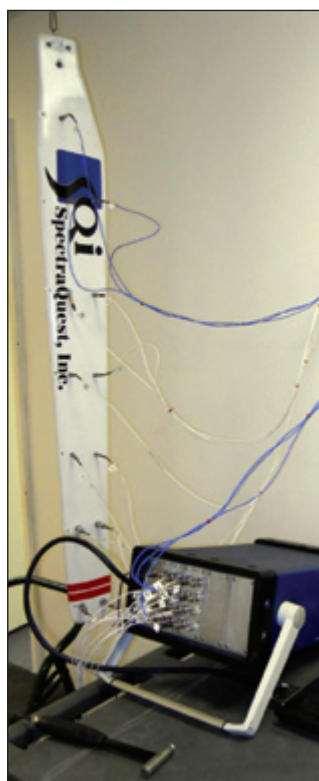
Figure 1. Blade test setup.

The blade test setup is shown in Figure 1. Thirteen accelerometers were attached to the surface of the blade, and it was impacted with an instrumented hammer at three locations – at each end and in the middle. The responses were simultaneously measured at 13 locations using a high-precision 16-channel data acquisition system. The 13 accelerometer locations are indicated in Figure 2.

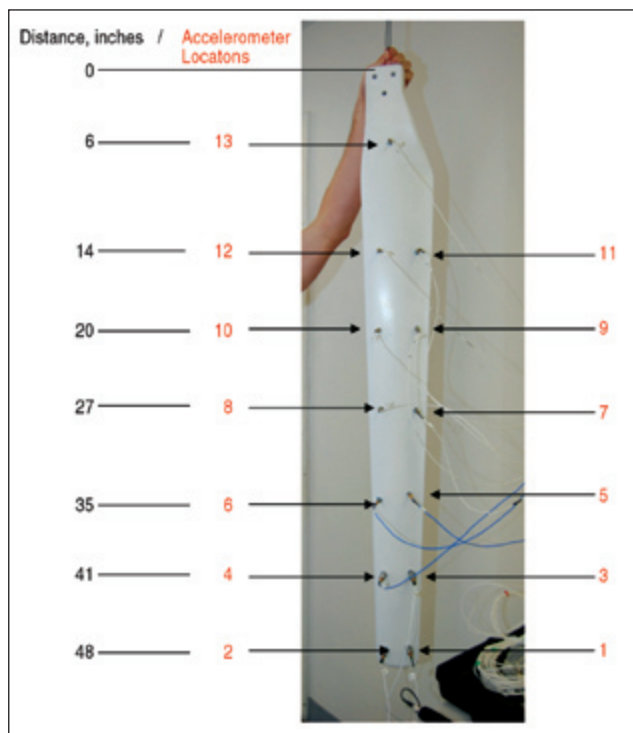
Figure 2. Accelerometer locations.

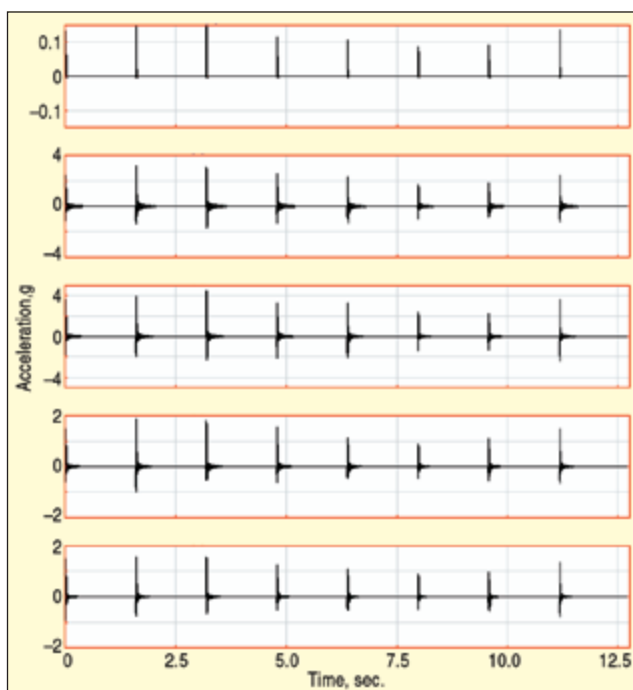
Figure 3. Typical time-domain records.

During impact testing, time domain records of 64,000 samples each were acquired from the impact hammer and the accelerometers. Each record contained data from eight consecutive impacts. Three sets of data were taken by impacting in the middle and at each end of the blade. A typical set of the acquired time records (one impact and four responses) is shown in Figure 3. Acquired time records were post-processed using tri-spectrum averaging (eight averages), with a

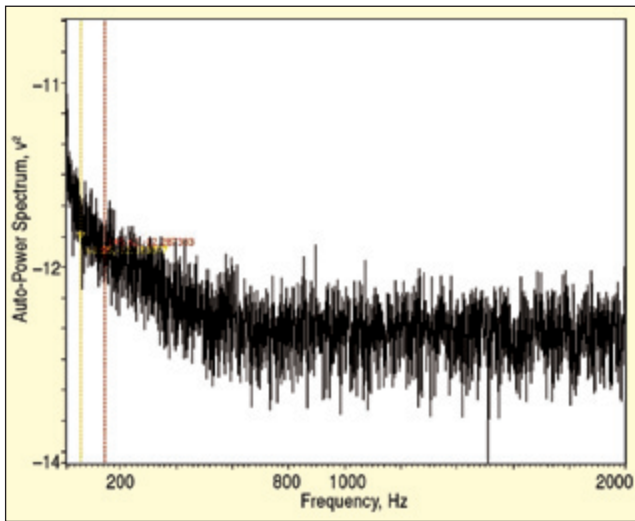
Figure 4. Typical power spectra of input data (0-2000 Hz).

Figure 4 shows a typical auto power spectrum of the hammer signal. The data show that the input spectra energy drops off significantly above 800 Hz. This means that blade modes above 800

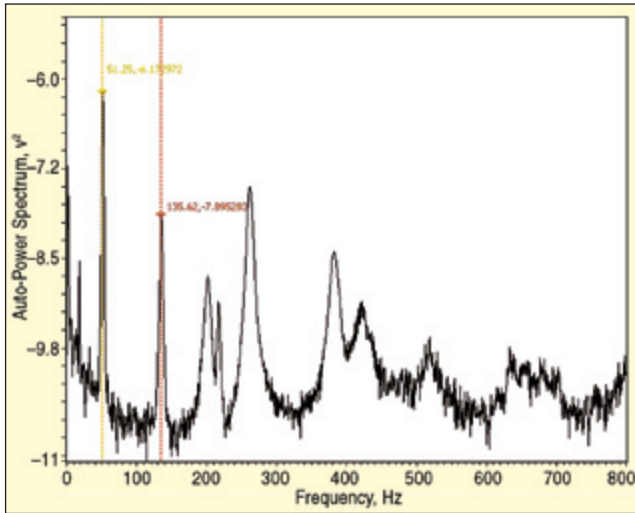
Figure 5. Typical power spectra of response data (0-800 Hz).

Hz were not excited during this test. A typical response auto power spectrum is shown in the Figure 5, which shows that multiple modes are excited in the frequency span (0 to 800 Hz).

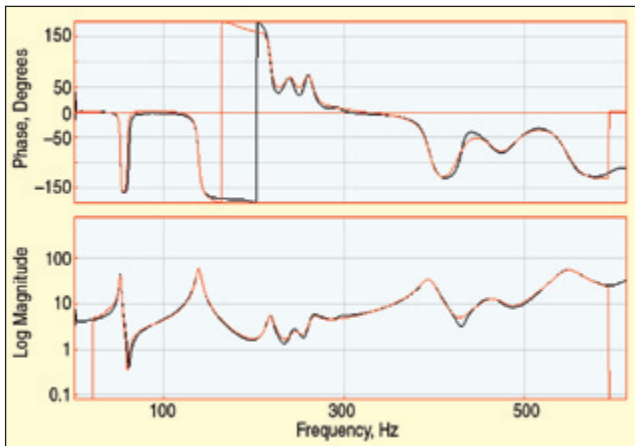
Figure 6. Typical FRF and fit function overlaid.

Frequency response functions (FRFs) were then calculated from the auto and cross spectra. A typical FRF is shown in Figure 6. Each FRF contained 4,000 samples of data over a frequency span of 0 to 2563.5 Hz with a frequency resolution of 0.64 Hz. The results are only shown over a frequency span of 0 to 800 Hz.

Modal parameters (frequency, damping, mode shape) were obtained by curve fitting each set of 13 FRFs. A red curve fit function is shown overlaid on the FRF data in Figure 6.

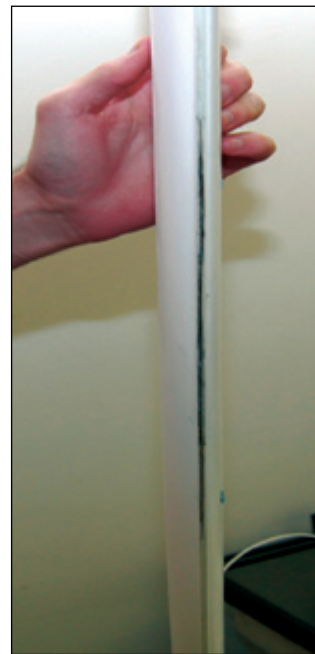
Figure 7. Edge crack.

The first blade failure was a series of induced cracks along one edge of the blade, as shown in Figure 7. The following four modal tests were performed:

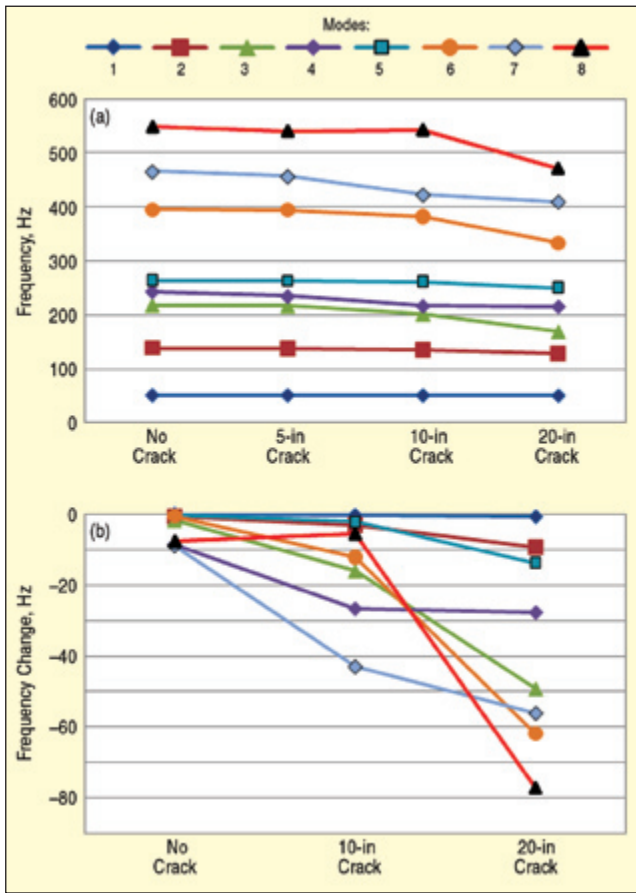
Figure 9. Edge crack modal frequencies (top) and frequency changes from baseline (bottom).

The modal frequencies obtained from the four edge-crack tests are plotted in Figure 9. As expected, the frequencies trend downward with increased severity of the crack. This is because the edge cracks caused

a decrease in the blade stiffness.

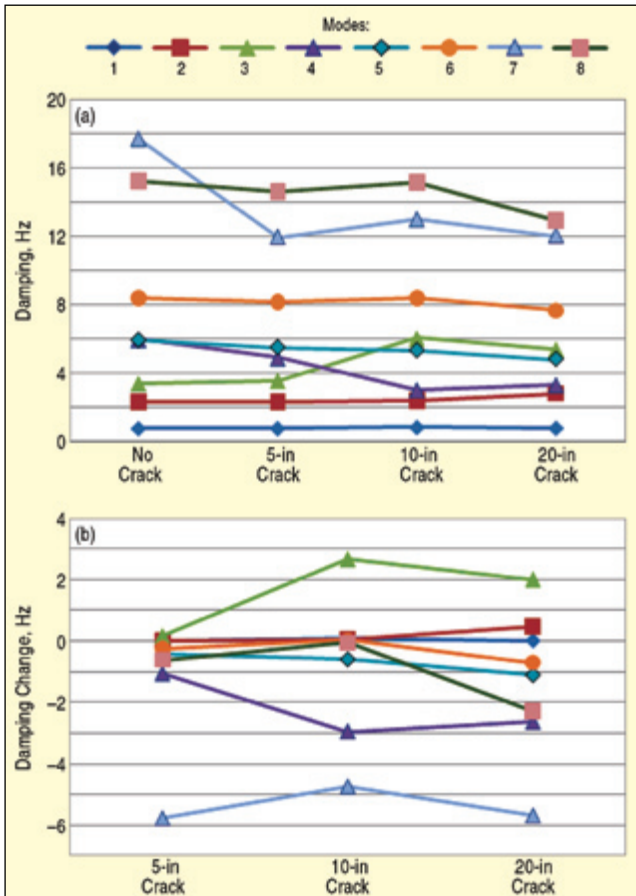
Figure 10. edge crack modal damping (top) and damping changes from baseline (bottom).

Modal damping for the four edge-crack cases is shown in Figure 10. Most of the damping changes from the baseline are negative, except for Modes 2 and 3, which are positive. A negative change means that the crack created less damping in the mode. A positive change means that the mode was more heavily damped than the baseline.

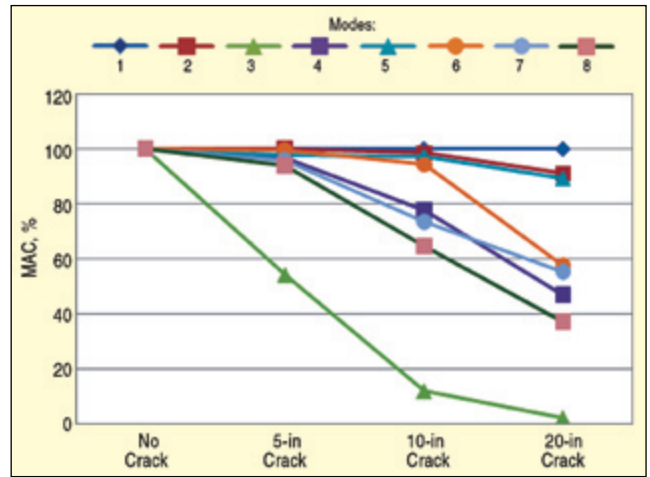
Figure 11. Edge crack mode shape MAC values.

Mode shape MAC (modal assurance criterion)³ values are commonly used to numerically compare two mode shapes. The MAC values for the four edge crack tests are shown in Figure 11. A MAC value of 100% indicates no change in the mode shape.

The MAC values indicate little significant change due to the 5-inch crack, except for Mode 3. However, the 10-inch and 20-inch cracks caused significant changes in the mode shapes of several – but not all – modes.

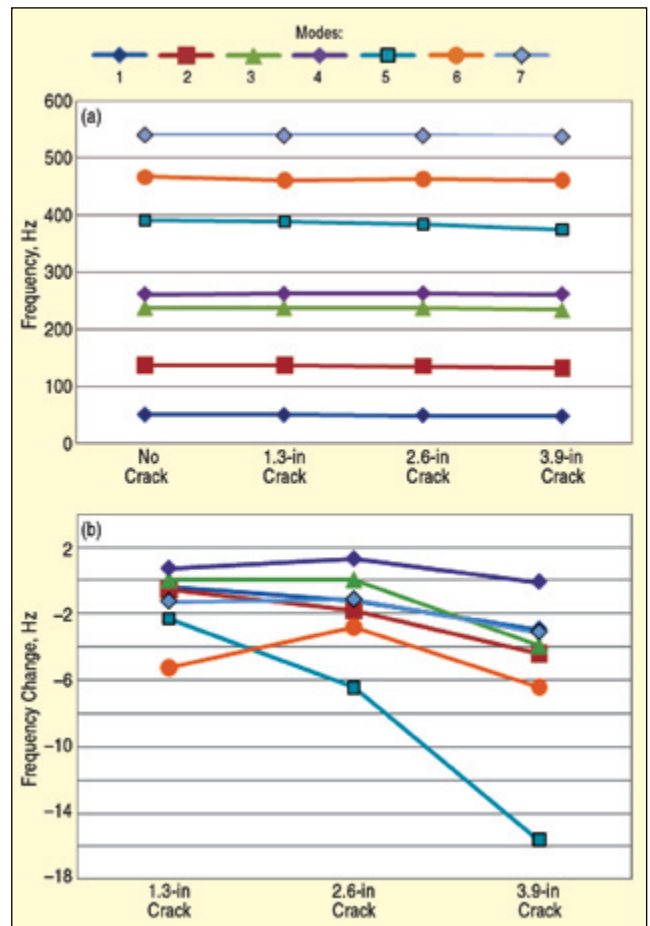
Figure 12. Face crack modal frequencies (top) and frequency changes from baseline (bottom).

The modal frequencies obtained from the four surface crack tests are plotted in Figure 12. Most of the frequencies trend downward with increased crack severity. This is expected because the crack causes a decrease in the blade stiffness, resulting in lower frequencies with increasing crack severity. One exception was noted for Mode 4, which trended upward for the 2.6-inch crack. This upward trend was not expected.

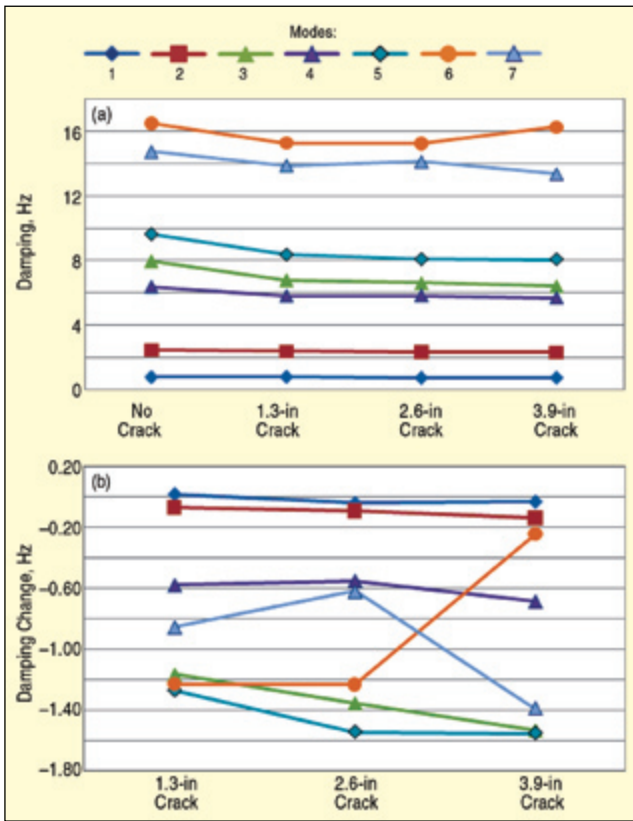
Figure 13. Face crack modal damping (top) and damping changes from baseline (bottom).

Modal damping for the four surface-crack cases is shown in Figure 13. The data indicate no significant change in the damping of the first two modes from the baseline, while the damping of all higher modes decreased. This is indicated by the negative from the baseline, meaning that the surface cracks created less damping in the blade. The result is somewhat surprising and should be investigated further.

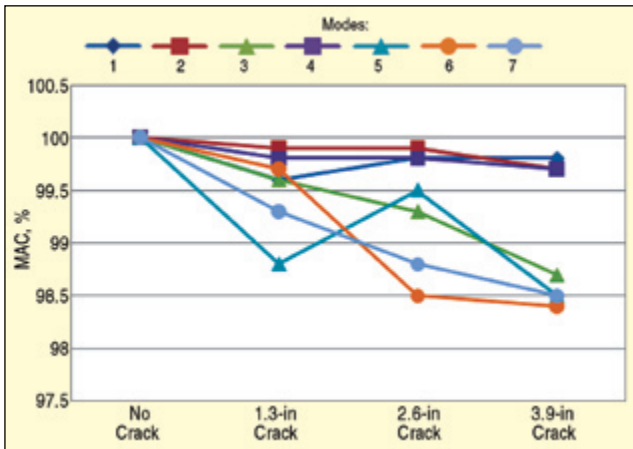
Figure 14. Face crack mode shape MAC values.

Mode shape MAC values for the four surface-crack tests are shown in Figure 14. All MAC values are above 98.4%. This means that all three surface cracks caused an insignificant change in the mode shapes.

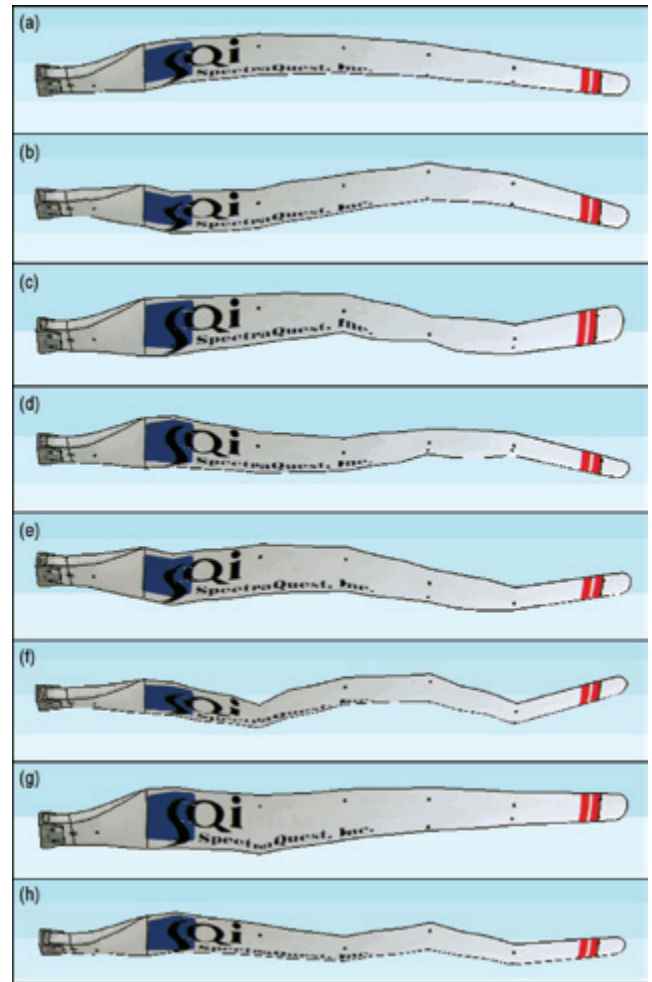
Figure 15. first eight mode shapes of the undamaged wind turbine blade: (a) 51.7 Hz, 1.48% damping; (b) 139 Hz, 1.68% damping; (c) 219 Hz, 1.55% damping; (d) 244 Hz, 2.45% damping; (e) 264 Hz, 2.45% damping; (f) 395 Hz, 2.12% damping; (g) 486 Hz, 3.8% damping; (h) 548 Hz, 2.77% damping.

The first eight mode shapes are shown in Figure 15. Because only 13 responses were acquired, the spatial resolution is at a minimum. Nevertheless, bending and torsional modes were clearly excited in the span (0 to 600 Hz).
