Optimizing Ceiling Systems and Lightweight Plenum Barriers

Gary S. Madaras, ROCKFON, Chicago, Illinois

Andrew E. Heuer, NGC Testing Services, Buffalo, New York

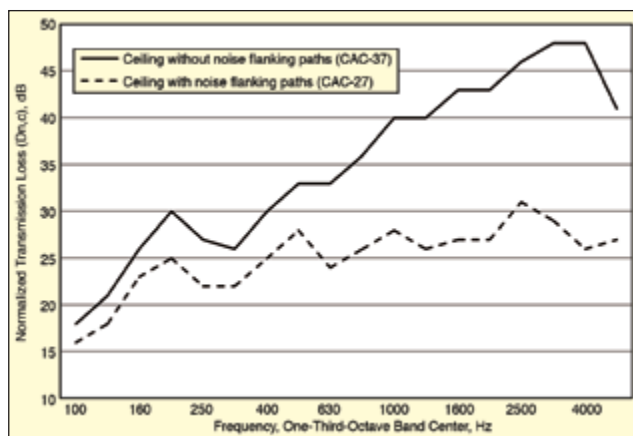
Figure 1. Noise flanking paths caused by common elements penetrating ceiling system can result in significant degradation to isolating capacity of ceiling system.²

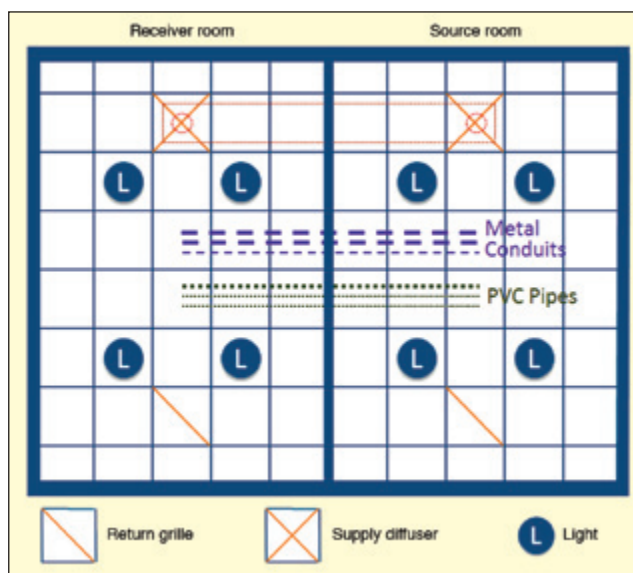
Figure 2. Reflected ceiling plan showing locations of lights and air devices during tests.

Detailed descriptions of the components used during the testing can be provided upon request. The ceiling panels were 5/8-inch-thick stone wool (NRC 0.75, CAC_{panel} 23). The grid was a standard 15/16-inch tee-bar grid installed in an *interrupted* manner, meaning the wall stopped flush with the top of the grid and panels. No grid members or panels spanned over the top of the wall. The return air grilles were open, egg-crate style. The supply diffusers were square, plaque style. A rigid metal supply air duct internally lined with 1-inch-thick fiberglass duct lining connected the two diffusers. The light fixtures were general-purpose T8 troffers with open, egg-crate louvers. Along with the duct, there were three PVC pipes and three metal conduits up to 4 inches in diameter running through the plenum over the central demising wall. Figure 2 shows the reflected ceiling plan with the locations of all air distribution devices, light fixtures, pipes and conduits.

Figures 8, 9 and 10 show the results of the testing. The baseline condition in all three figures is a ceiling system with stone wool panels and all of the noise flanking paths shown in Figure 2. No flanking path noise remediation was used. For each of the tested plenum barriers, this baseline ceiling system was maintained.

The figures also include the results of a ceiling system with mineral fiber panels for reference purposes only. The test specimen was a ceiling system comprised of 5/8-inch-thick mineral fiber panels (CAC_{panel} 37) and all of the same noise flanking paths shown in Figure 2. The flanking paths decreased the CAC_{panel} from 37 to CAC_{system} of 27. The data for the mineral fiber ceiling panels are included in the figures so that the relatively small effect of the type of ceiling panel on overall isolation can be seen compared to the more substantial effect of the plenum barriers being studied. Also, people are more familiar with mineral fiber panels than with stone wool ceiling panels, so including their data preempts the anticipated question of how a mineral fiber ceiling panel would compare.

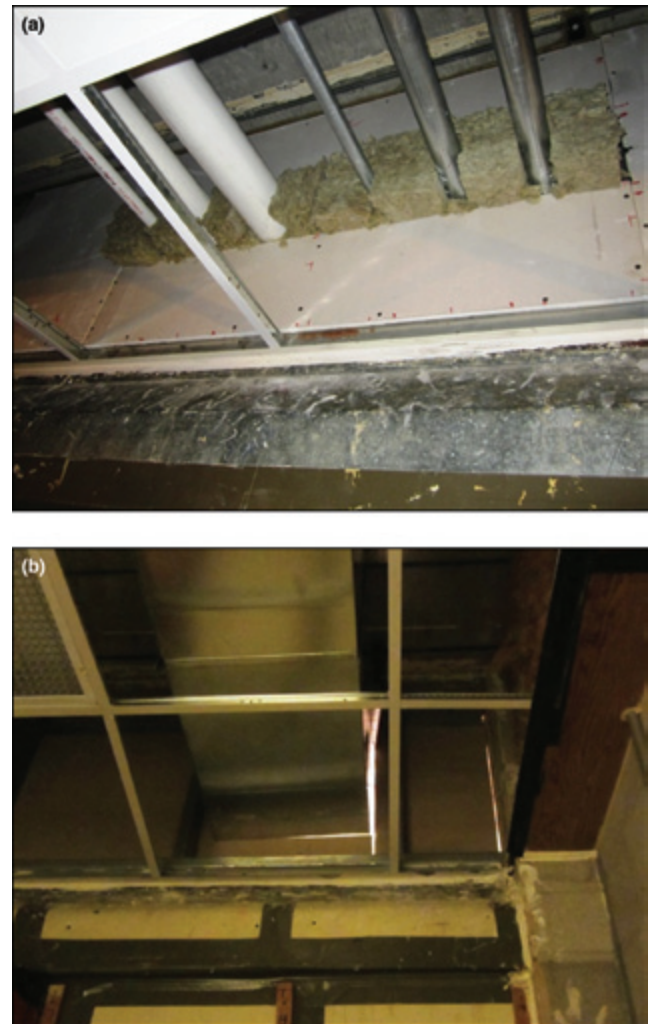
Figure 4. A quick installation technique was used for some of the drywall barriers: (a) large openings were left around the penetrating elements so simple rectangular pieces of drywall could be used; those openings were stuffed with pieces of stone wool insulation; (b) large gaps between pieces of drywall and around the penetrating elements were not caulked or taped; light shining through the gaps from the opposite side of the barrier show their size and extent.

Two installation techniques were used for the drywall plenum barriers; *quick* and *sealed*. Figure 4 shows the quick installation technique using rough-cut, rectangular pieces of drywall. There were large gaps and openings, especially around the elements that penetrated the plenum barrier. Large openings were stuffed with scraps of stone wool insulation. Smaller gaps were left open. No tape or caulk was used. Some of the open gaps were as large as 1 inch wide and 24 inches long.

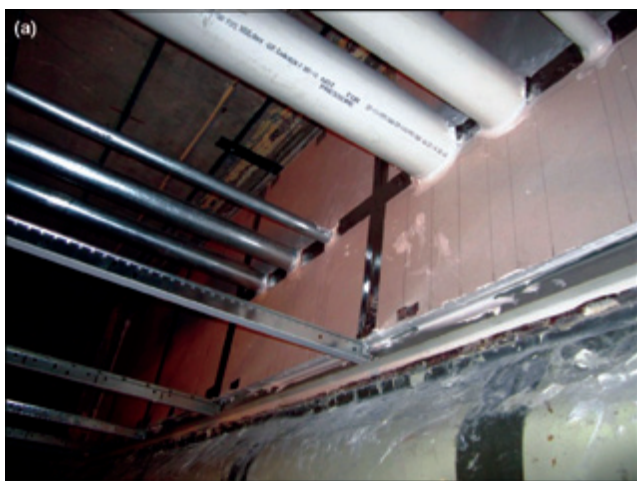
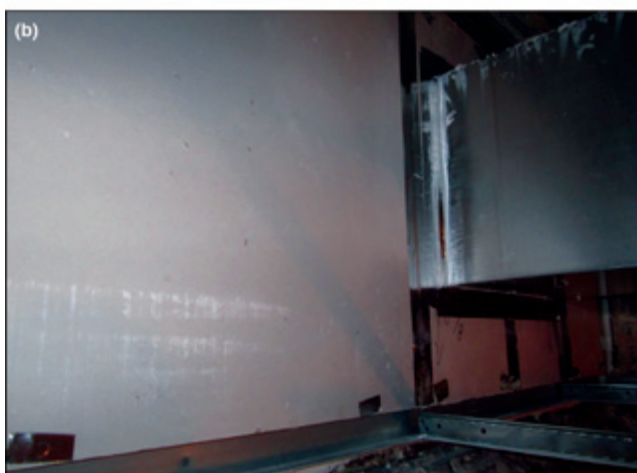
Figure 5. A sealed installation technique was used for some of the drywall barriers: (a) drywall was cut closely around the penetrating elements and caulked; (b) joints, screw heads and penetrations were sealed with metal tape.

Figure 5 shows the *sealed* drywall installation technique using drywall that was cut close around the penetrating elements. Gaps were generally less than a half inch wide. Joints and screw heads were sealed with metal tape, and gaps around the penetrating elements were sealed with flexible caulk.

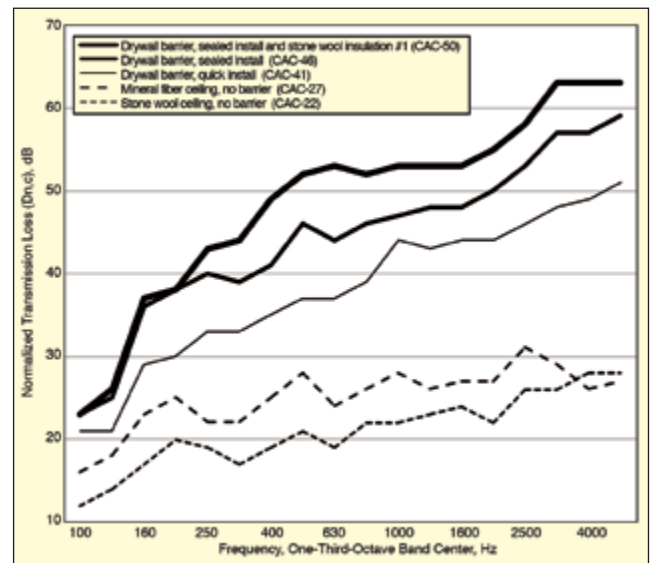
Figure 8. Use of lightweight, drywall, plenum barriers with ceiling systems increases inter-room sound isolation by 14 - 28 CAC points compared with using ceiling systems alone; plenum barriers make total blocking capacity of the ceiling/plenum path more similar to blocking capacity of STC 40, 45 and 50 walls below the ceiling.

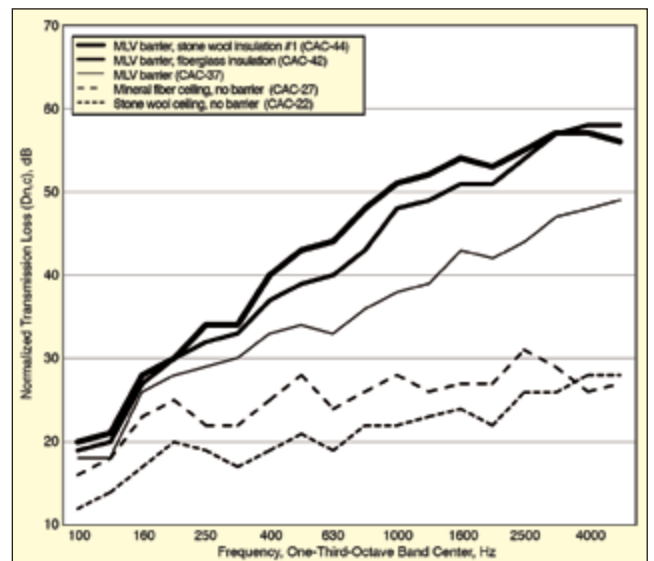
Figure 9. Use of lightweight, MLV, plenum barriers with ceiling systems increases inter-room sound isolation by 10 - 22 CAC points compared with using ceiling systems alone; plenum barriers make total blocking capacity of the ceiling/plenum path similar to blocking capacity of STC 40 and STC 45 walls below the ceiling.

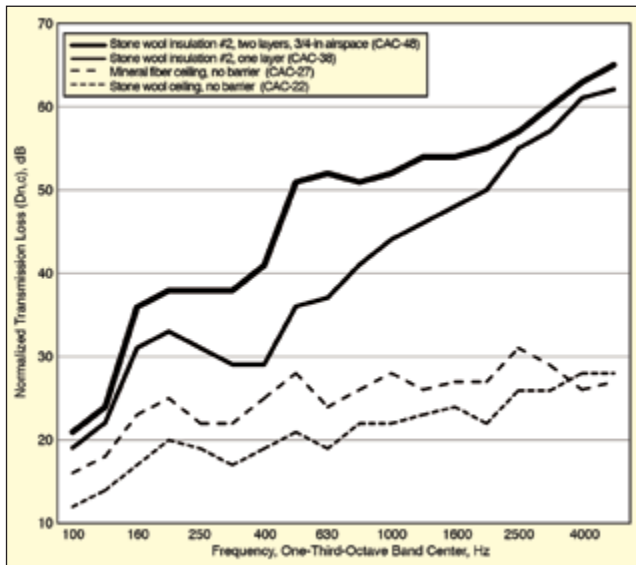
Figure 10. Use of lightweight, stone wool insulation, plenum barriers with ceiling systems increases inter-room sound isolation by 11 - 26 CAC points compared with using ceiling systems alone; plenum barriers make total blocking capacity of the ceiling/plenum path similar to blocking capacity of STC 40, 45 and 50 walls below the ceiling.
